Level One Inspection and Testing Services

Meridian Central Estate, Stage 23,
Lots 2301 to 2329

Our Ref: 3807351.023.v1

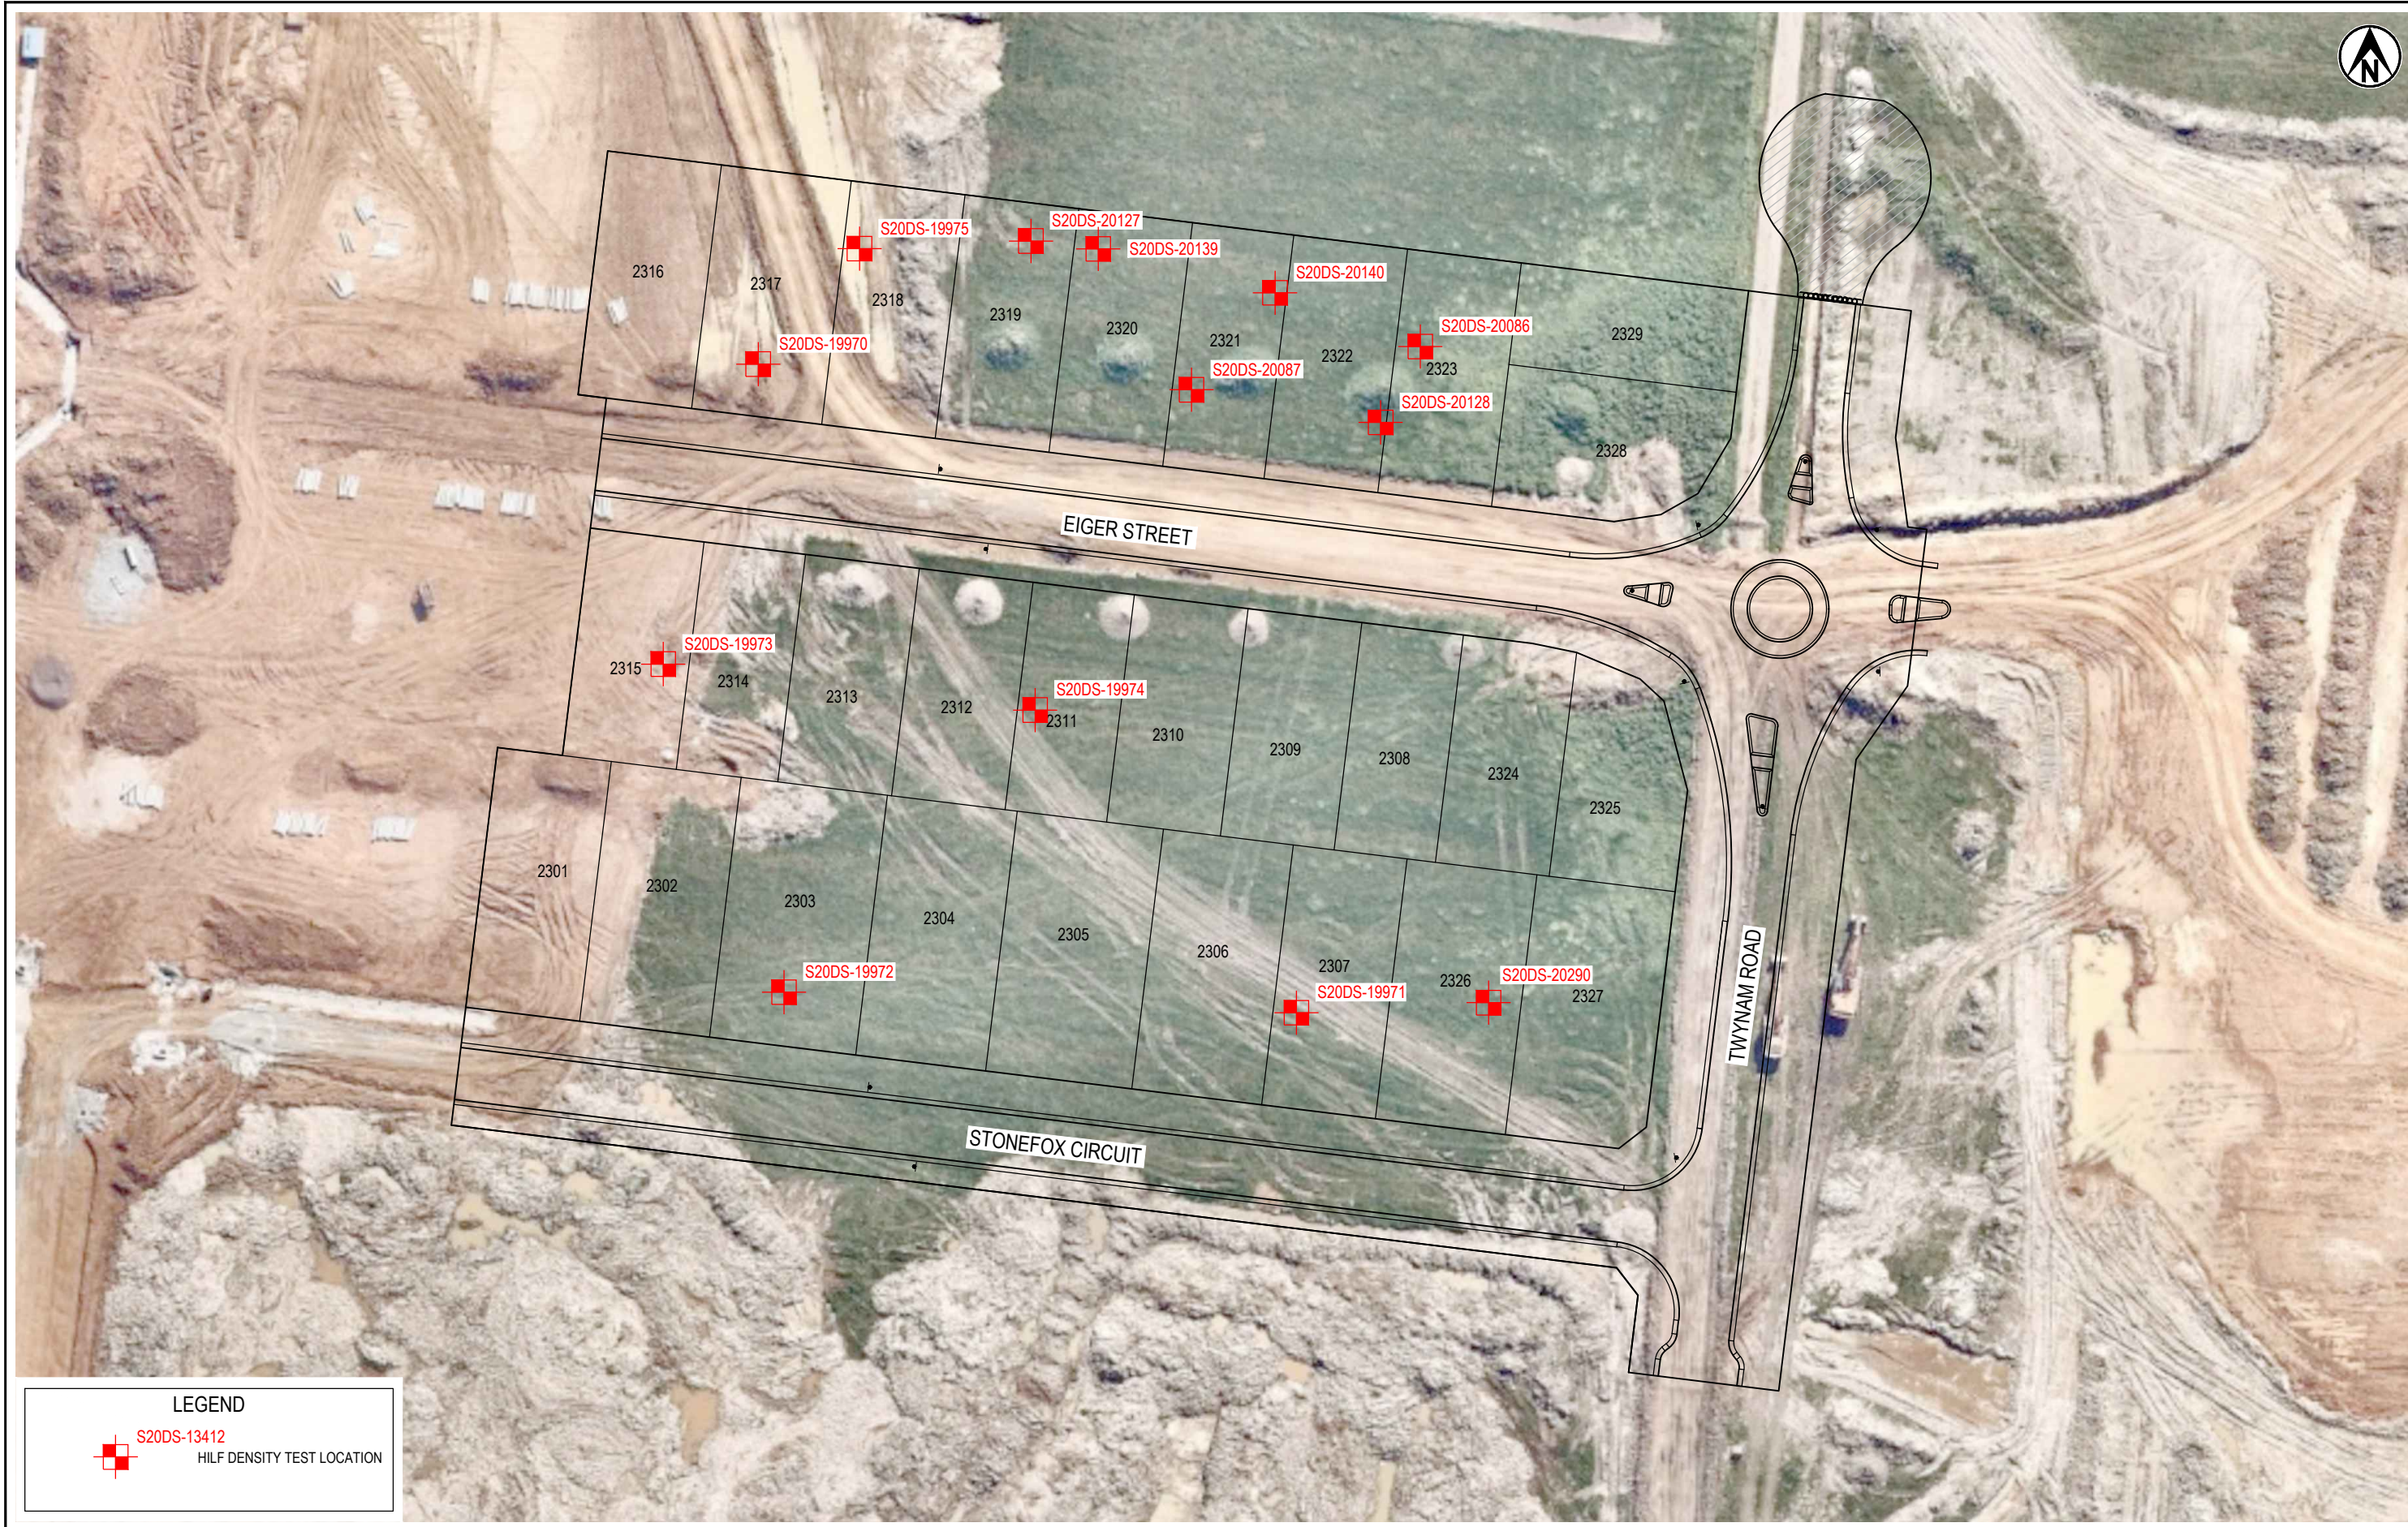
CLIENT	GROSVENOR LODGE PTY LTD
PROJECT	MERIDIAN ESTATE - STAGE 23
TITLE	LEVEL ONE HILF DENSITY TESTING HILF DENSITY TEST PLAN
SCALE (A3)	1:750
FIG No.	FIGURE 01
REV	1

Field density and moisture content testing was carried out using a calibrated portable density and moisture gauge in accordance with AS 1289.5.8.1. The HILF rapid compaction test was used for peak converted wet density determinations in accordance with AS 1289.5.7.1. Test locations were recorded using a handheld GPS unit. A site plan showing the field density test locations is provided in Appendix A.
