Level One Inspection and Testing Services

Meridian Central Estate Stage 27, Clyde
Lot's 2701 to 2713, 2722 to 2725, 2726 to
2731, 2733 to 2740 and Superlot 27A

Grosvenor Lodge Pty Ltd

Our Ref: 3807351.027.v1

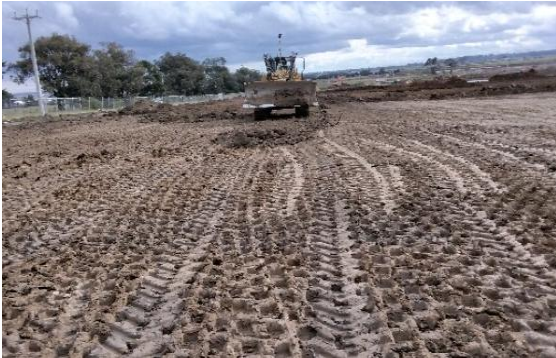
Photograph 2.1:
Earthwork operations, June 2021

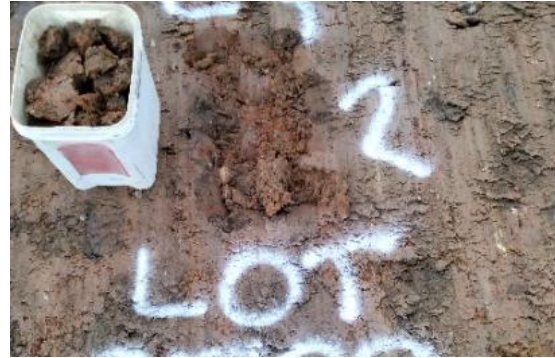
Photograph 2.2:
Earthwork Testing, June 2021
