Level One Inspection and Testing Services

Meridian Central Estate Stage 28, Clyde
Lot's 2801 to 2804 and 2820 to Lot 2843

29 October 2021

Our Ref: 3807351.028.v1

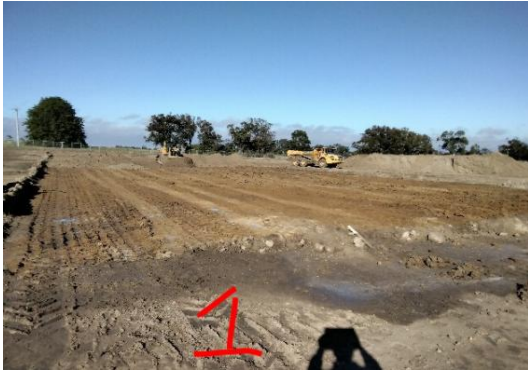
All fill material was placed in lift sequences and Chadwick Geotechnics verified that the surface of the stripped subgrade and additional lifts were thoroughly scarified, and moisture conditioned prior to placement of additional layers to prevent delamination at the layer interface. See Photographs 2.1 and 2.2 below.

Photograph 2.1:
Material Delivery, May 2021

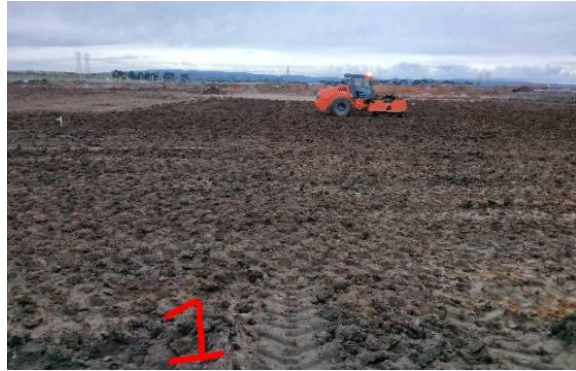
Photograph 2.2:
Material Compaction, June 2021

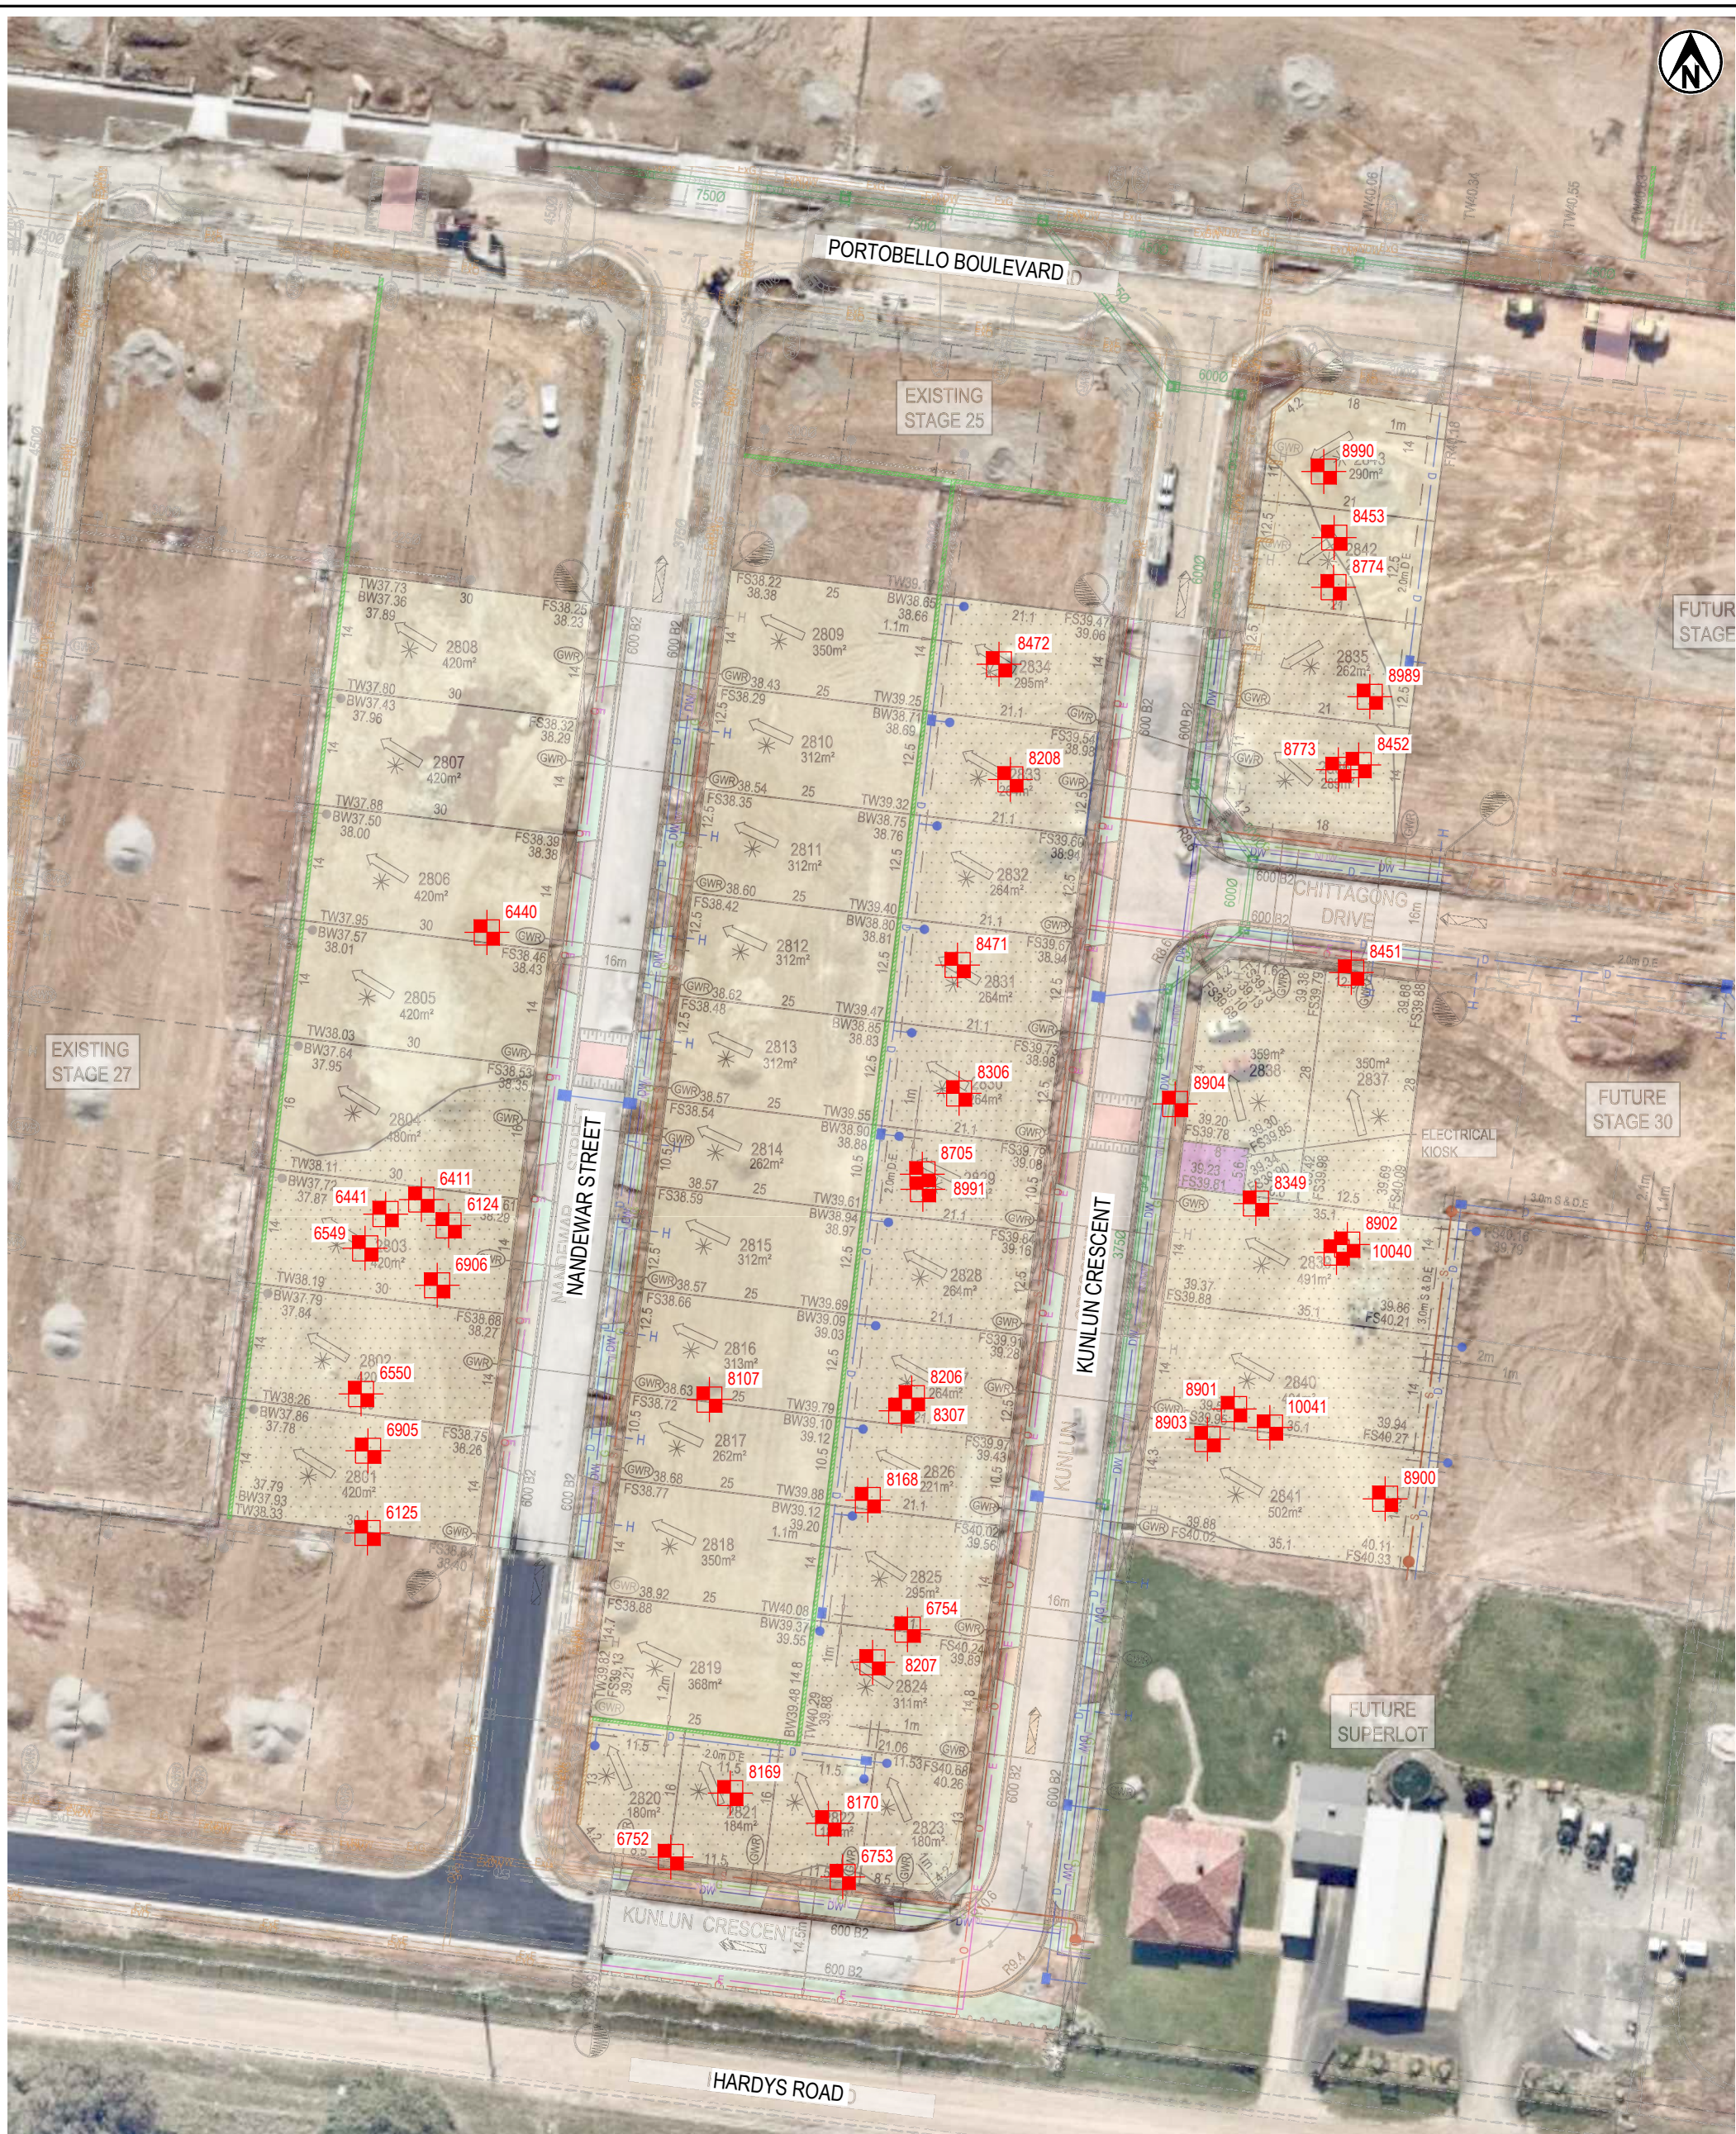
CLIENT	GROSVENOR LODGE PTY LTD	
PROJECT	MERIDIAN ESTATE - STAGE 28	
TITLE	LEVEL ONE HILF DENSITY TESTING HILF DENSITY TEST LOCATION PLAN	
SCALE (A3)	1:750	
FIG No.	FIGURE 01	
REV	1

The results show that 2 tests failed to meet the specification requirements for the project. The earthworks contractor was advised of the tests that failed and the fill relevant to those areas was reworked, reconditioned, re-compacted and subsequently retested. The final results show the tests achieved the specification requirements for the project.
