# **REPORT**

# Level One Inspection and Testing Services

Meridian Central Estate Stage 29, Clyde Lot 2911

Our Ref: 3807351.029.v1

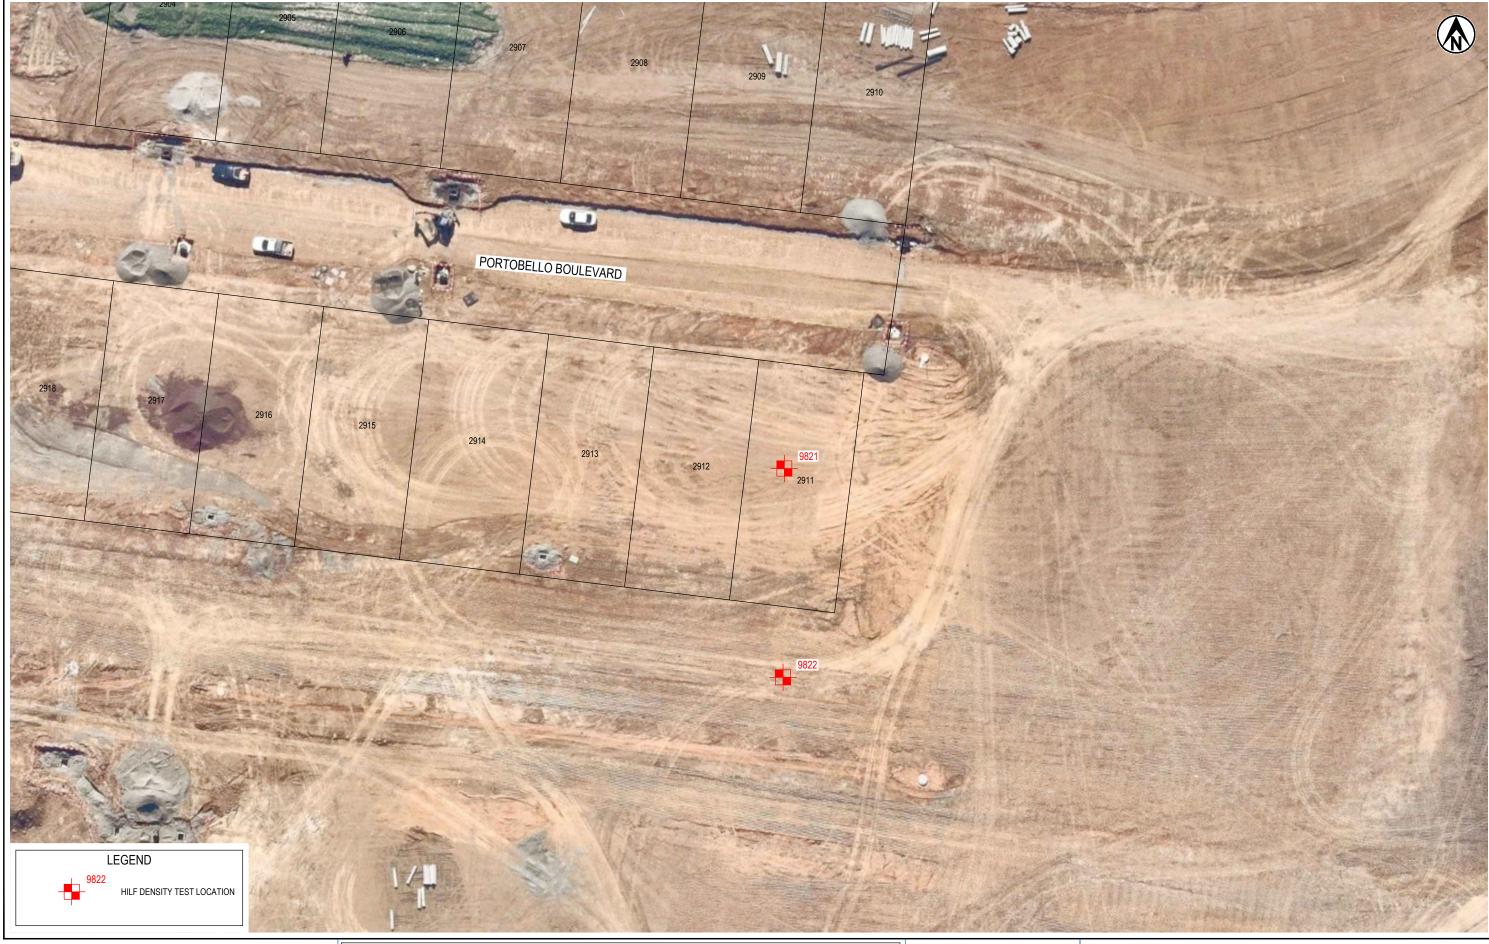
SCALE (A3) 1:500 FIG No. FIGURE 01

HILF DENSITY TEST LOCATION PLAN
