REPORT

Level One Inspection and Testing Services

Meridian Central Estate Stage 30, Clyde
Lot's 3001 & 3011 to Lot 3037

Our Ref: 3807351.030.v1

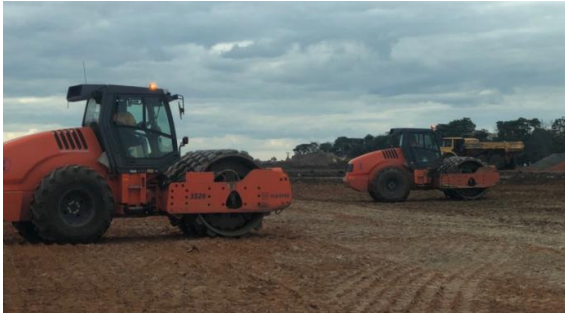
Photograph 2.1:
Material Compaction, August 2021

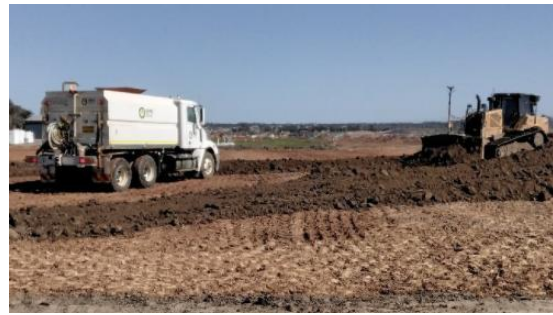
Photograph 2.2:
Moisture Conditioning, September 2021
