REPORT

Level One Inspection and Testing Services

Meridian Central Estate Stage 31, Clyde
Lot's 3113 to 3120 & Lot's 3123 to 3140

13 April 2022

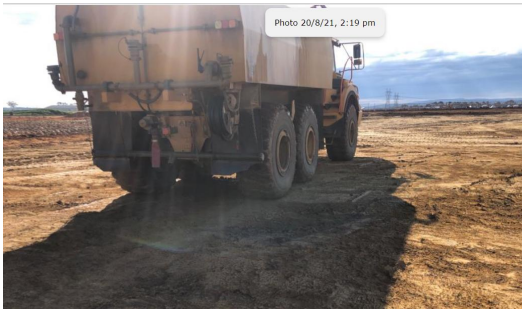
Photograph 2.1:
Material conditioning August 2021

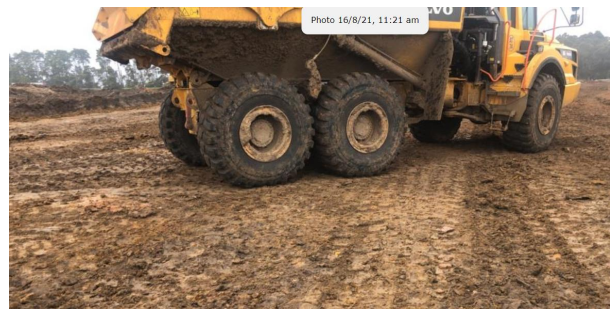
Photograph 2.2:
Material delivery August 2021

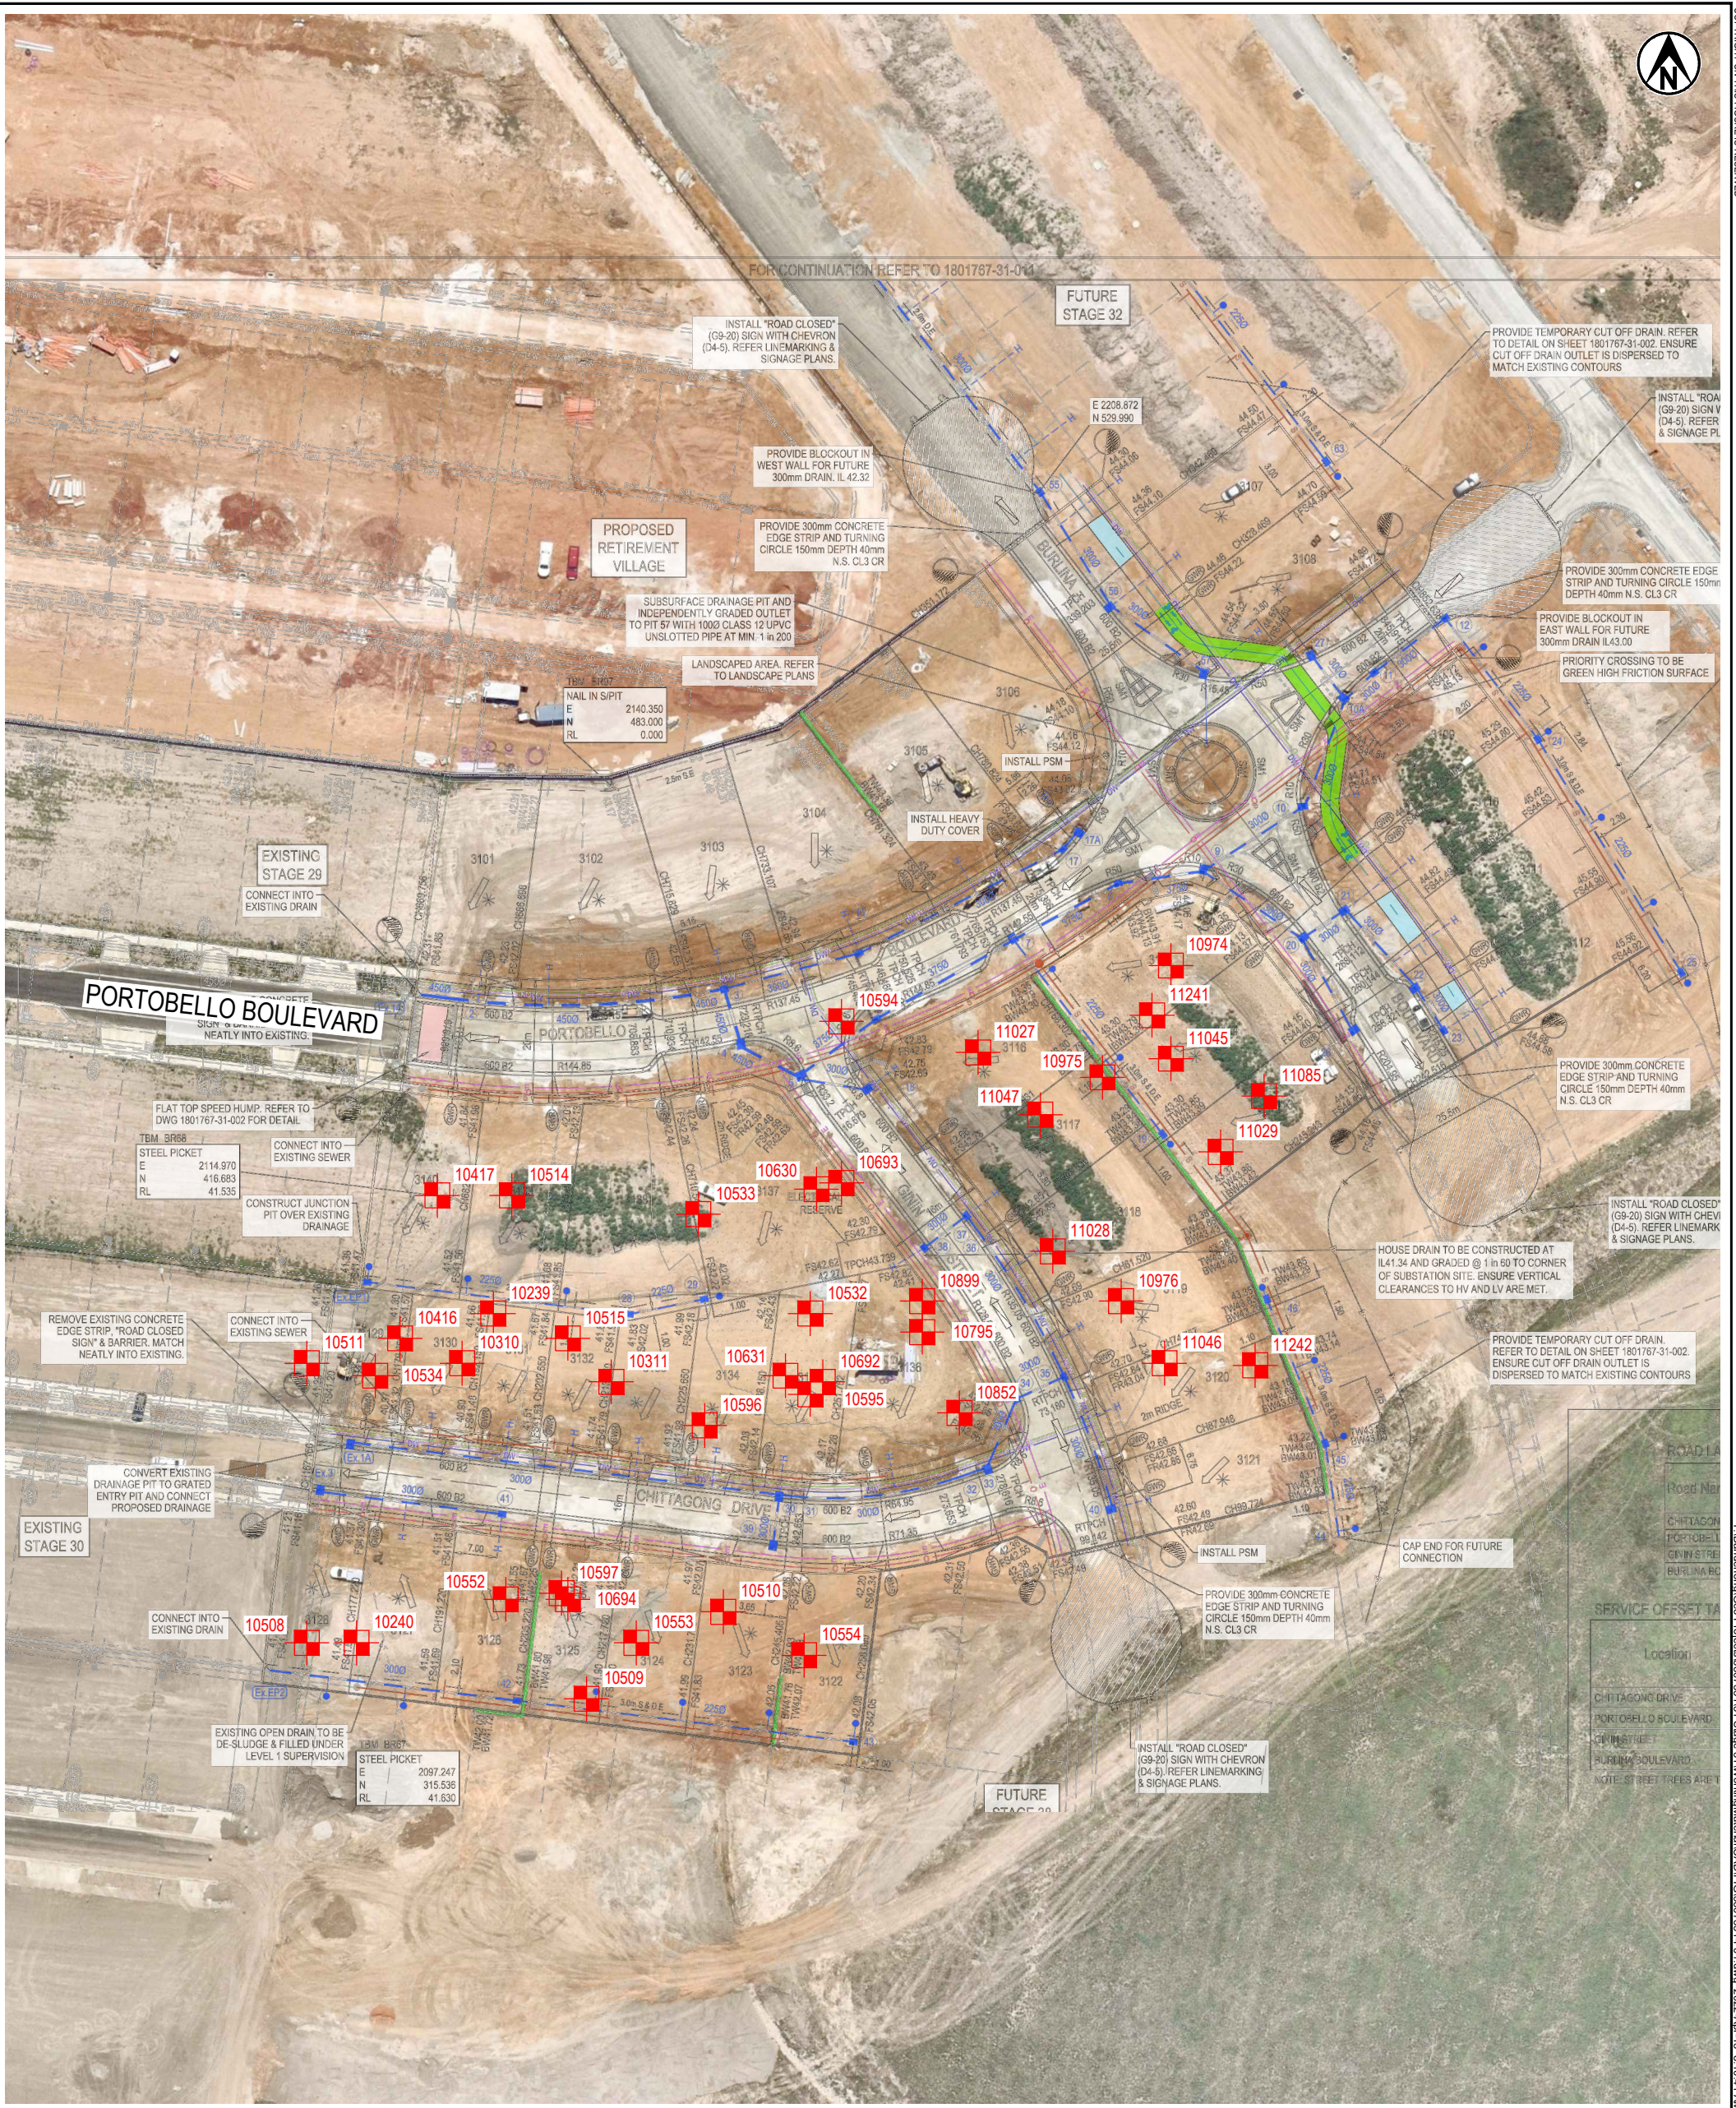
CLIENT	GROSVENOR LODGE PTY LTD	
PROJECT	MERIDIAN ESTATE - STAGE 31	
TITLE	LEVEL ONE HILF DENSITY TESTING HILF DENSITY TEST LOCATION PLAN	
SCALE (A3)	1:1000	FIG No. FIGURE 01
REV	1

The results show that 1 test failed to meet the specification requirements for the project. The earthworks contractor was advised of the test that failed and the fill relevant to the area was reworked, reconditioned, re-compacted and subsequently retested. The result showed that the test achieved the specification requirements for the project so far.
