# REPORT

## Level One Inspection and Testing Services

Meridian Central Estate Stage 32, Clyde  
Lot's 3203 to 3210 & Lot's 3218 to 3228

Our Ref: 3807351.032.v1

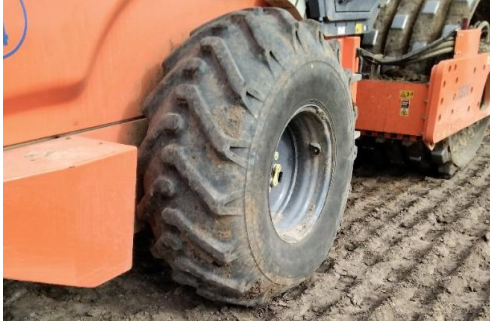
Photograph 2.7.1:  
Material compaction

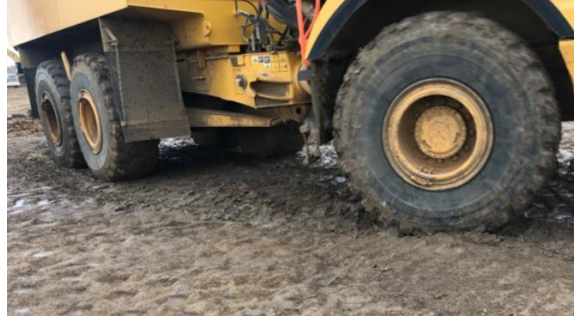
Photograph 2.7.2:  
Material conditioning
