REPORT

Level One Inspection and Testing Services

Meridian Central Estate Stage 33, Clyde
Lot's 3301 to 3305 & Lot's 3331 to 3334

Our Ref: 3807351.033.v1

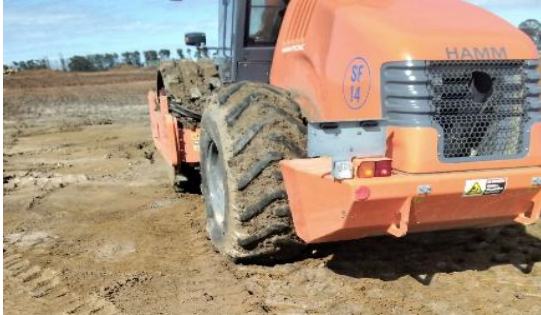
Photograph 2.7.1: Material Compaction

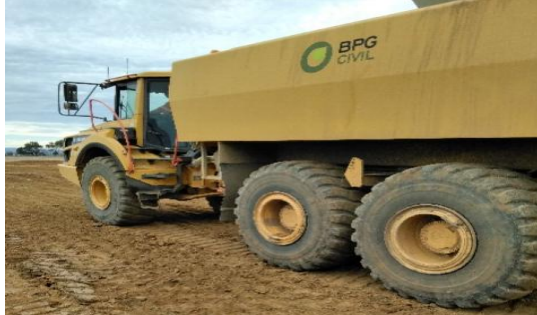
Photograph 2.7.2: Material conditioning

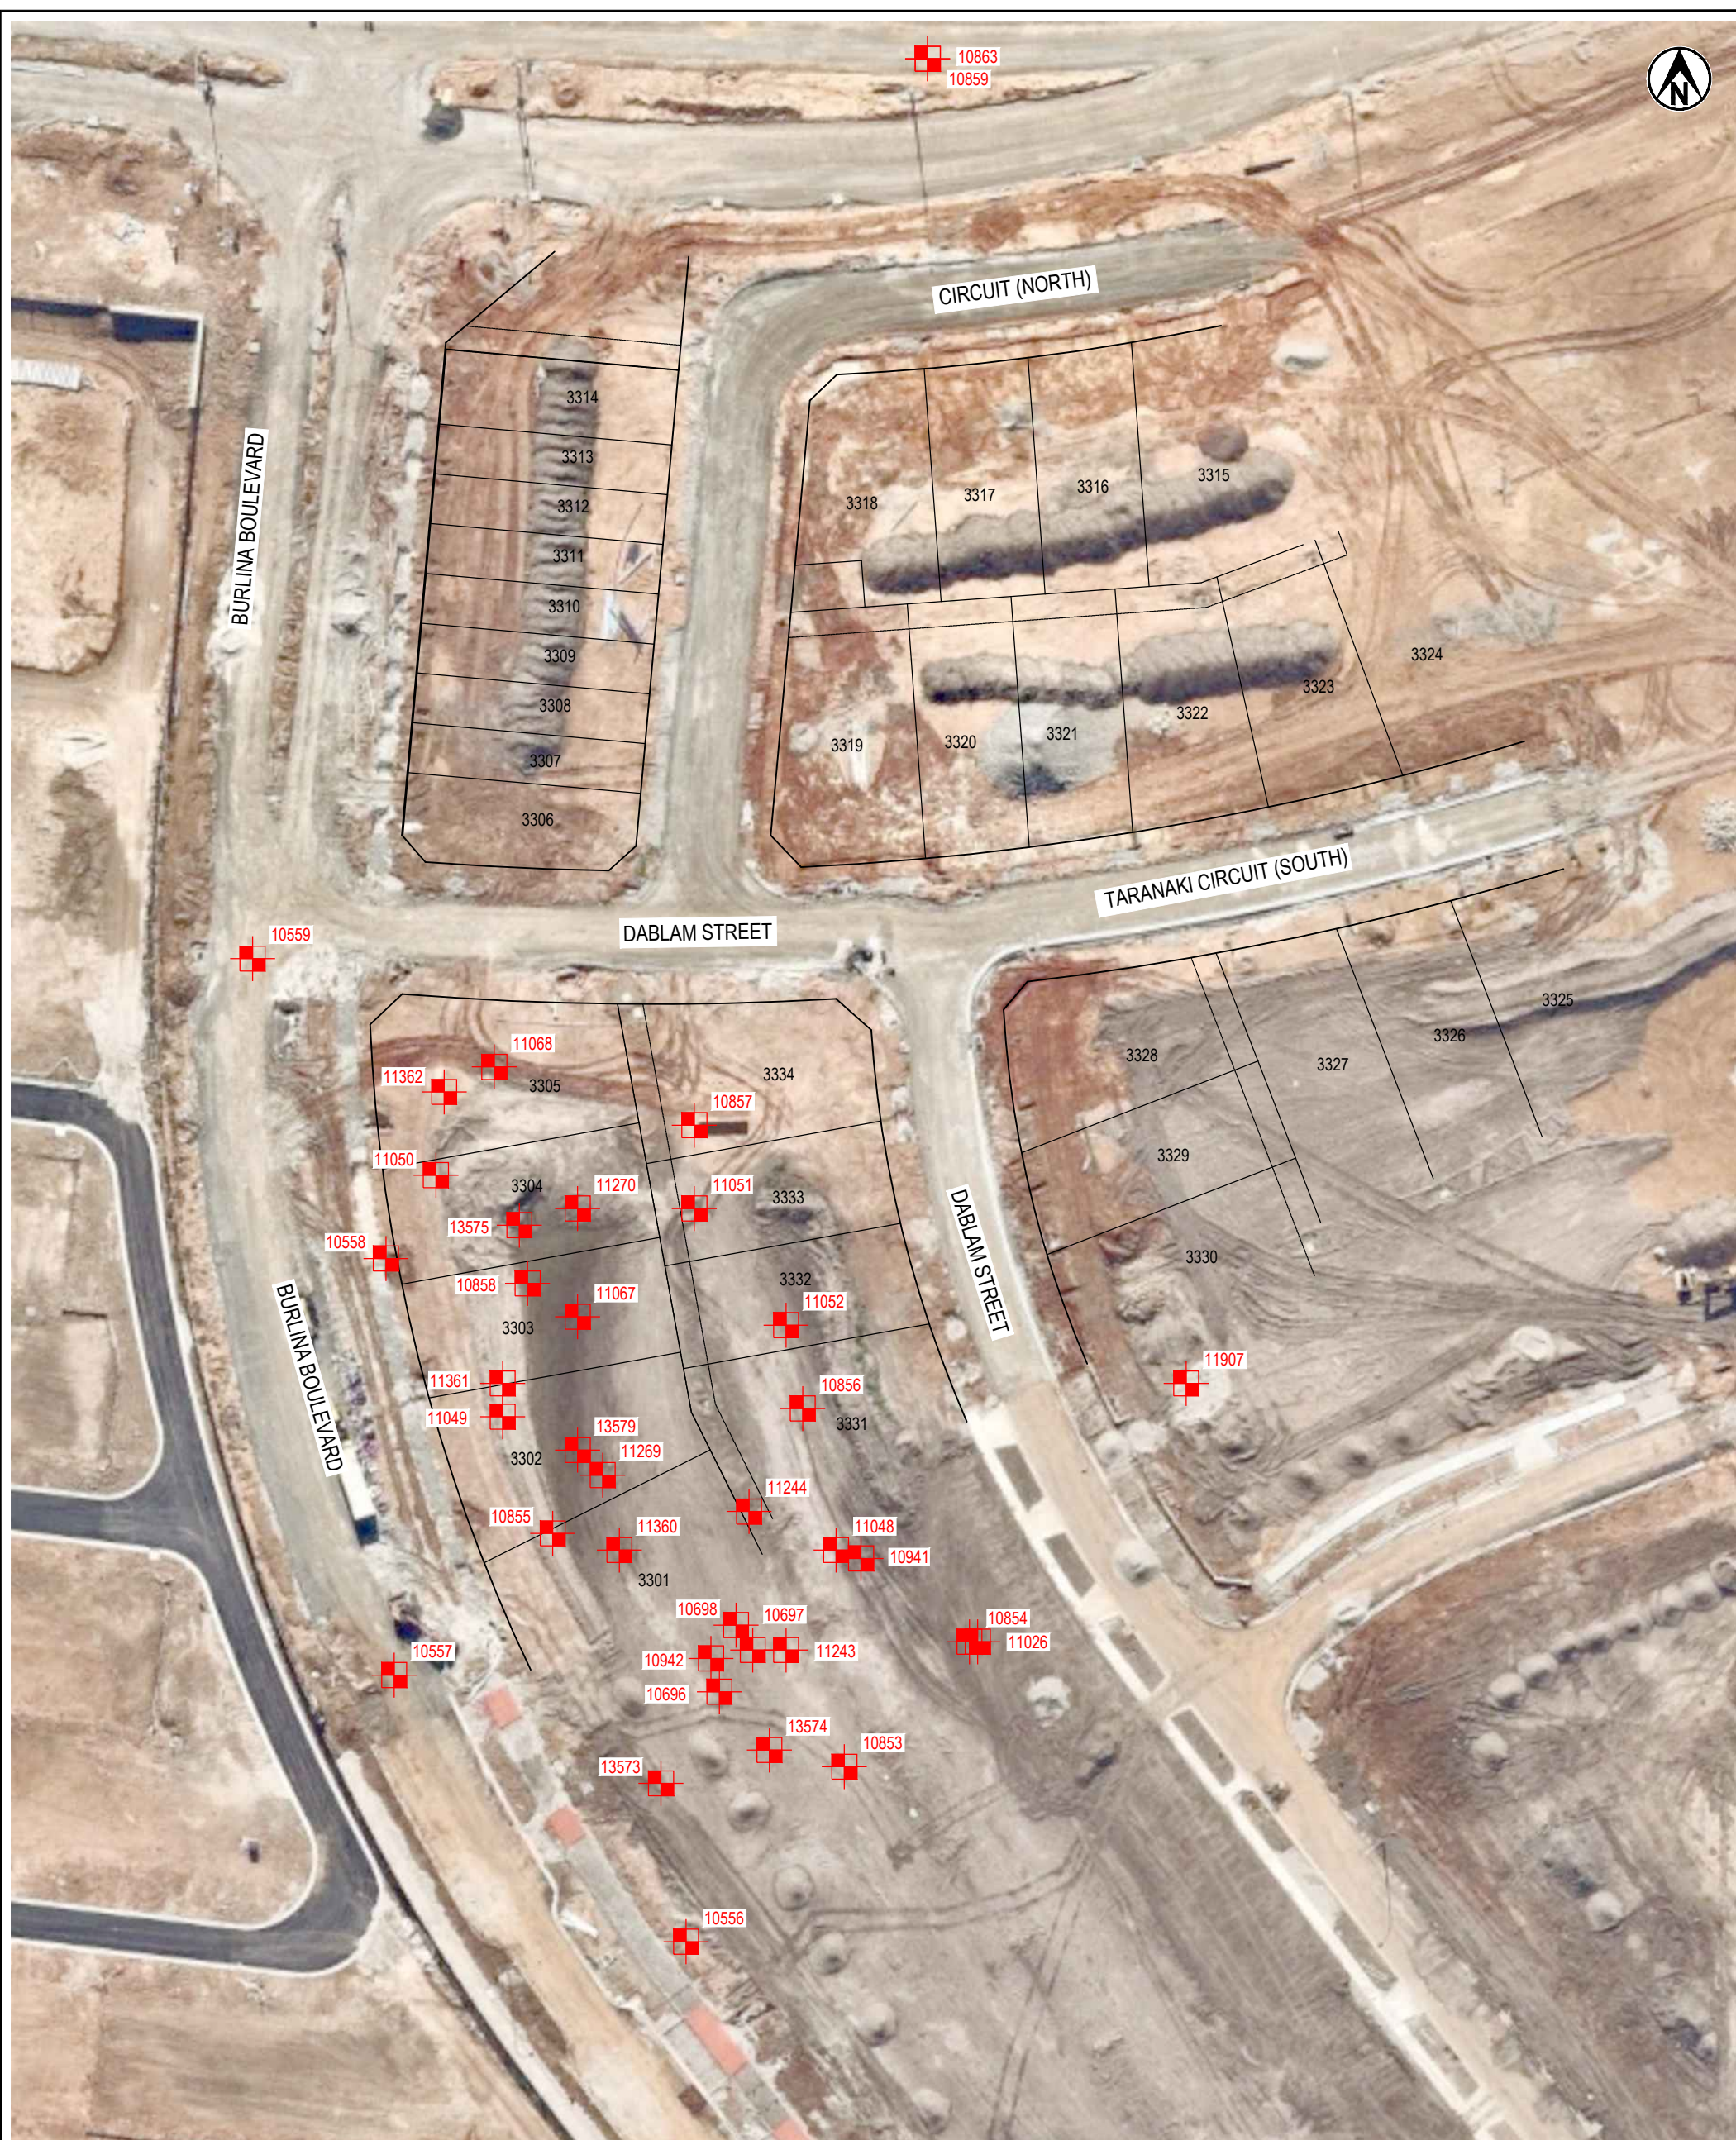
Appendix A: Site plan

A site plan showing the field density test locations is provided in Appendix A, A summary of the Hilf density test reports is provided within Appendix B and all the test reports are provided within Appendix C, a controlled fill certificate is provided within Appendix D.
