REPORT

Level One Inspection and Testing Services

Meridian Central Estate Stage 37, Clyde
Lot's 3701 to 3717

Our Ref: 3807351.037.v1

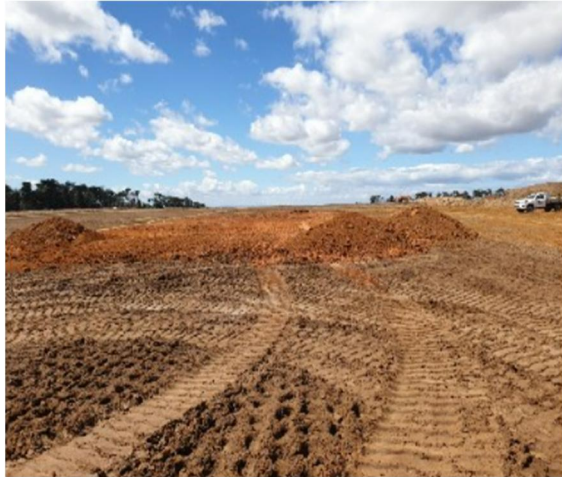
Photograph 3. Material ready for placement	Photograph 4: Orange sandy Clay

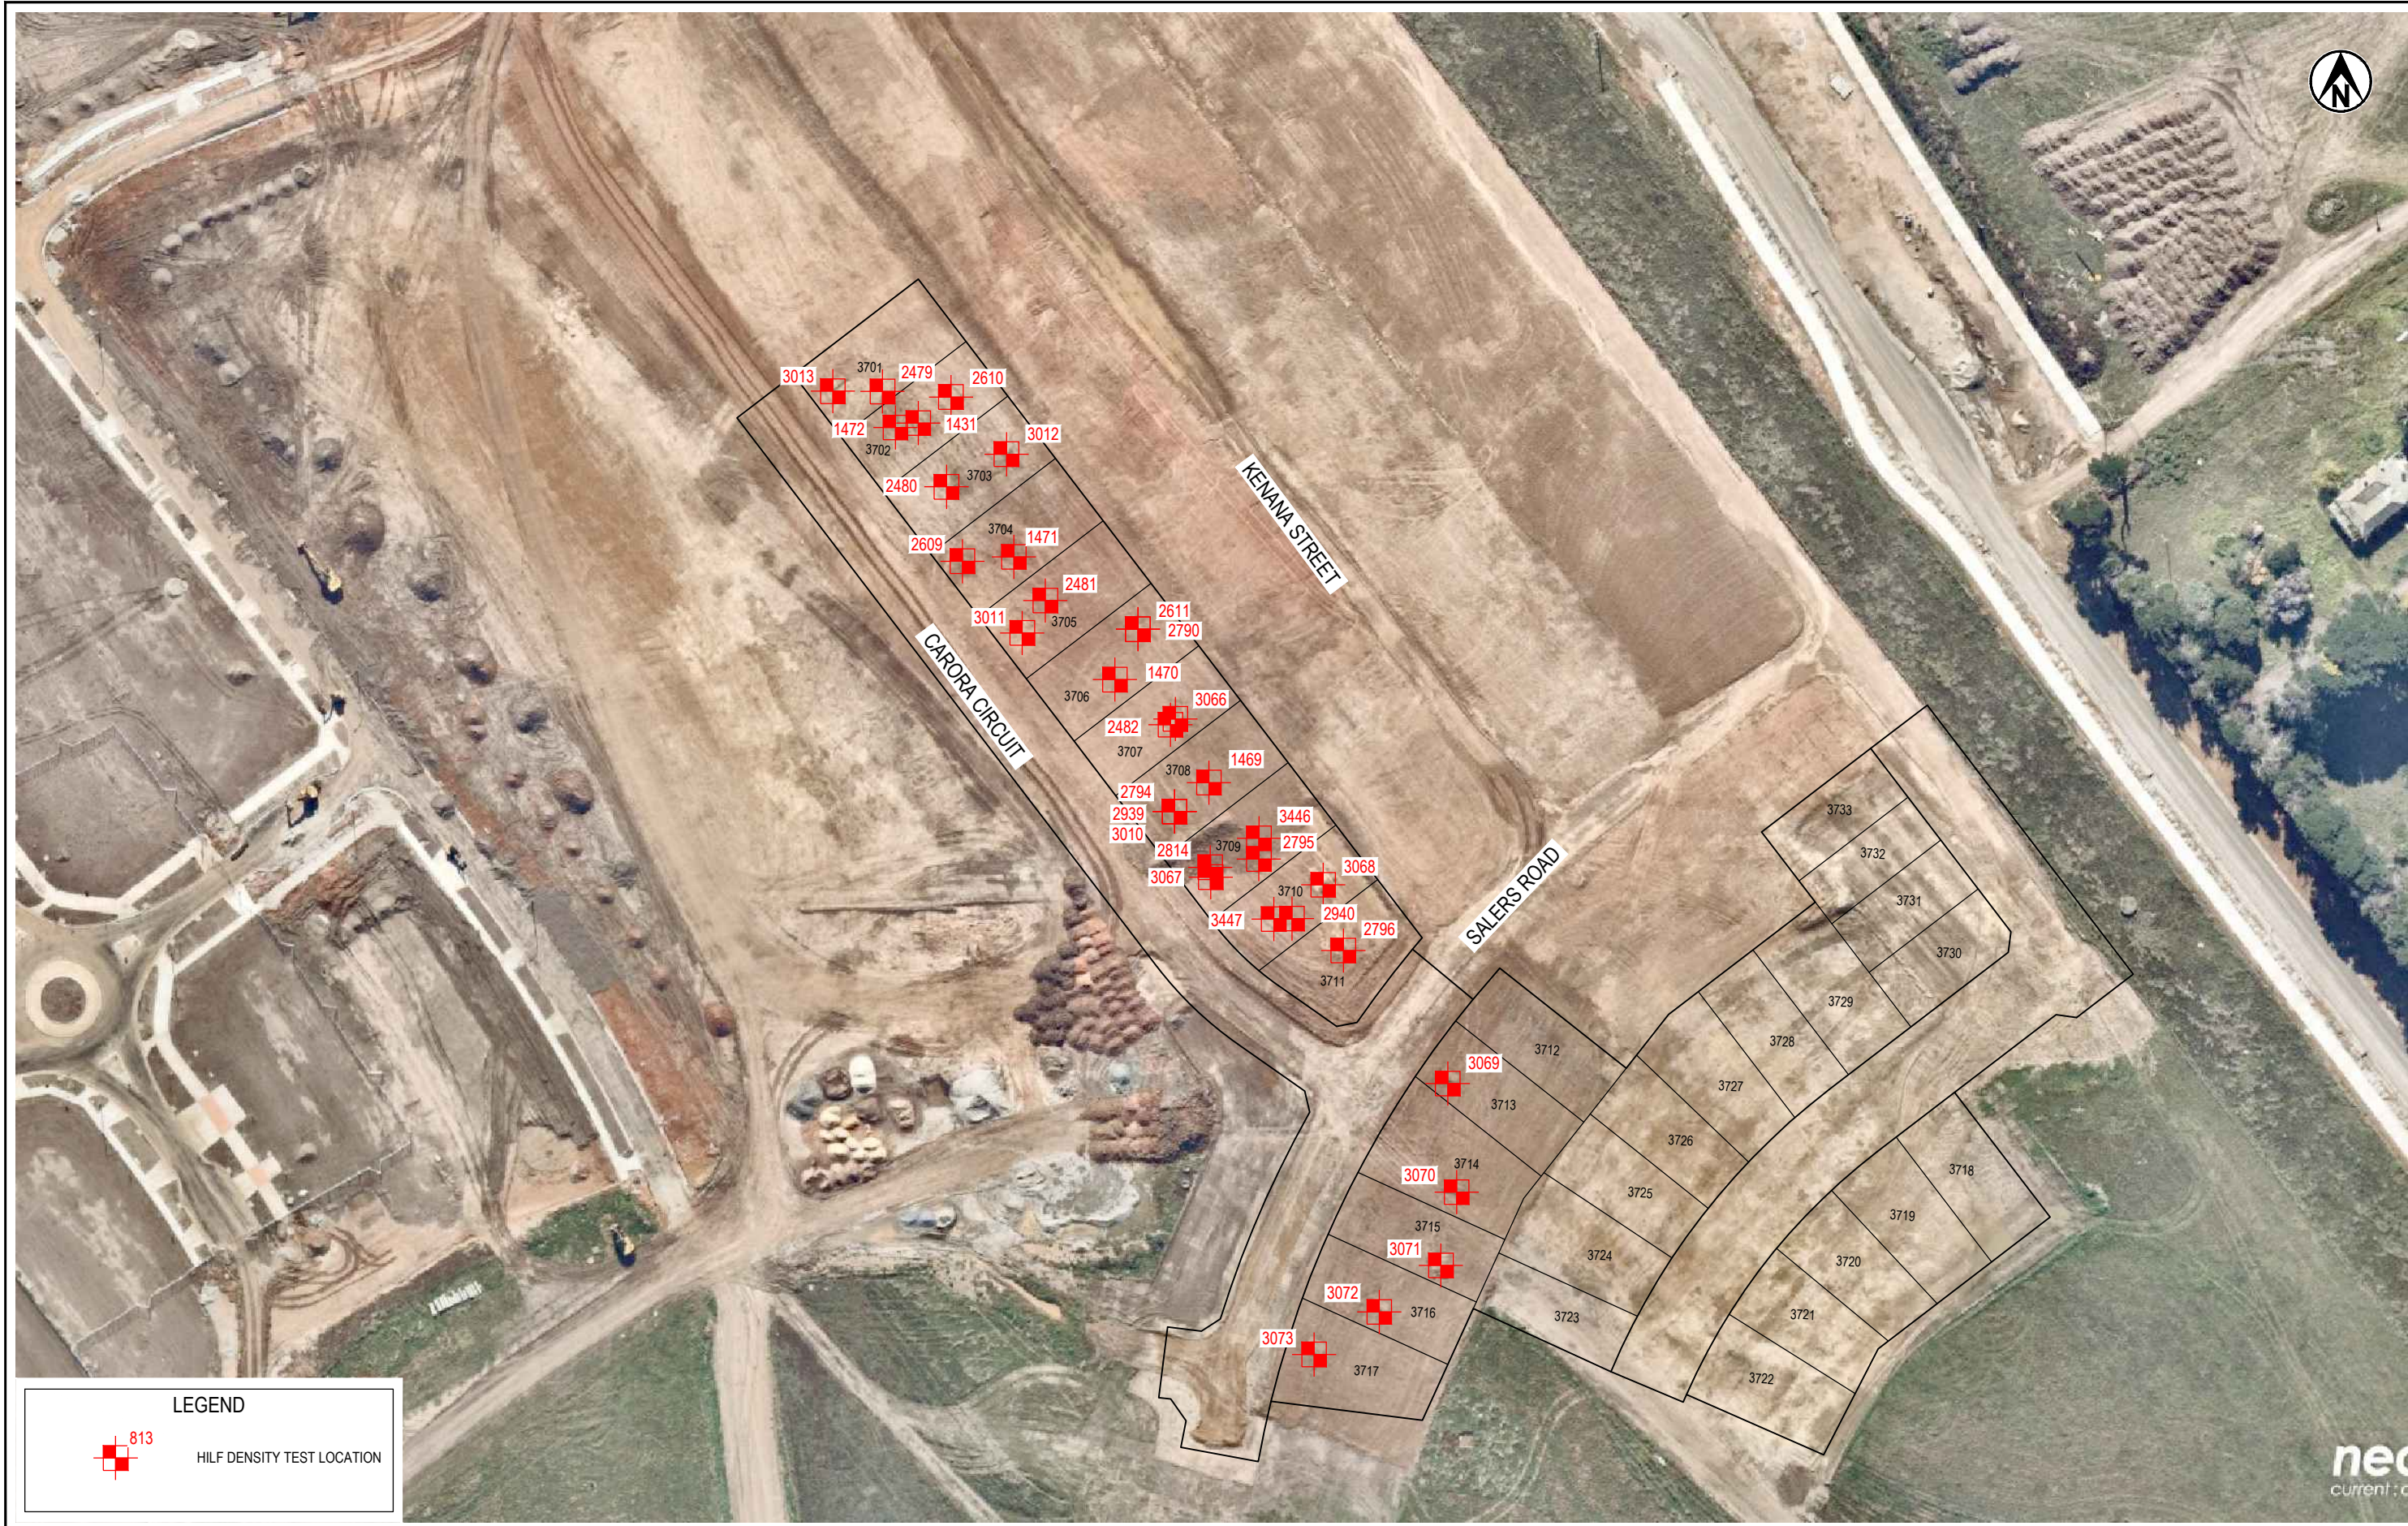
CLIENT	GROSVENOR LODGE PTY LTD	
PROJECT	MERIDIAN ESTATE - STAGE 37	
TITLE	LEVEL 1 HILF DENSITY TESTING HILF DENSITY TEST LOCATION PLAN	
SCALE (A3)	1:1250	FIG No. 3807351-F01
		REV 1

A site plan showing the field density test locations is provided in Appendix A. A summary of the Hilt density test reports is provided within Appendix B, and the laboratory test reports are provided within Appendix C. The Controlled Fill Certificate is provided within Appendix E.
