Level One Inspection and Testing Services

**Meridian Central Estate Stage 38, Clyde
Lot's 3801 to 3840**

Our Ref: 3807351.038.v1

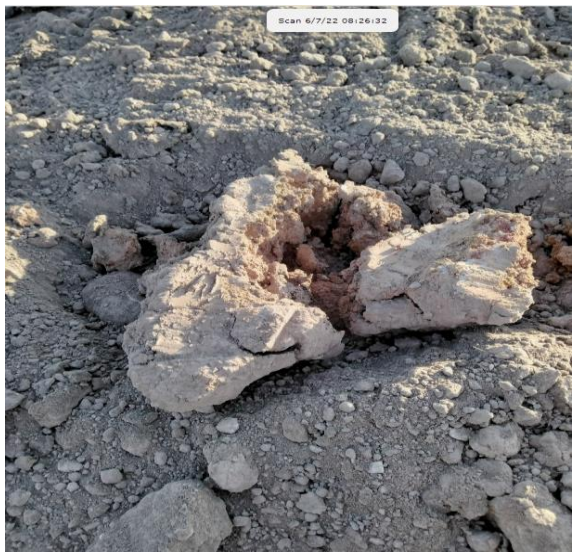
Photograph 3. Material ready for placement	Photograph 4: Brown Silty Clay

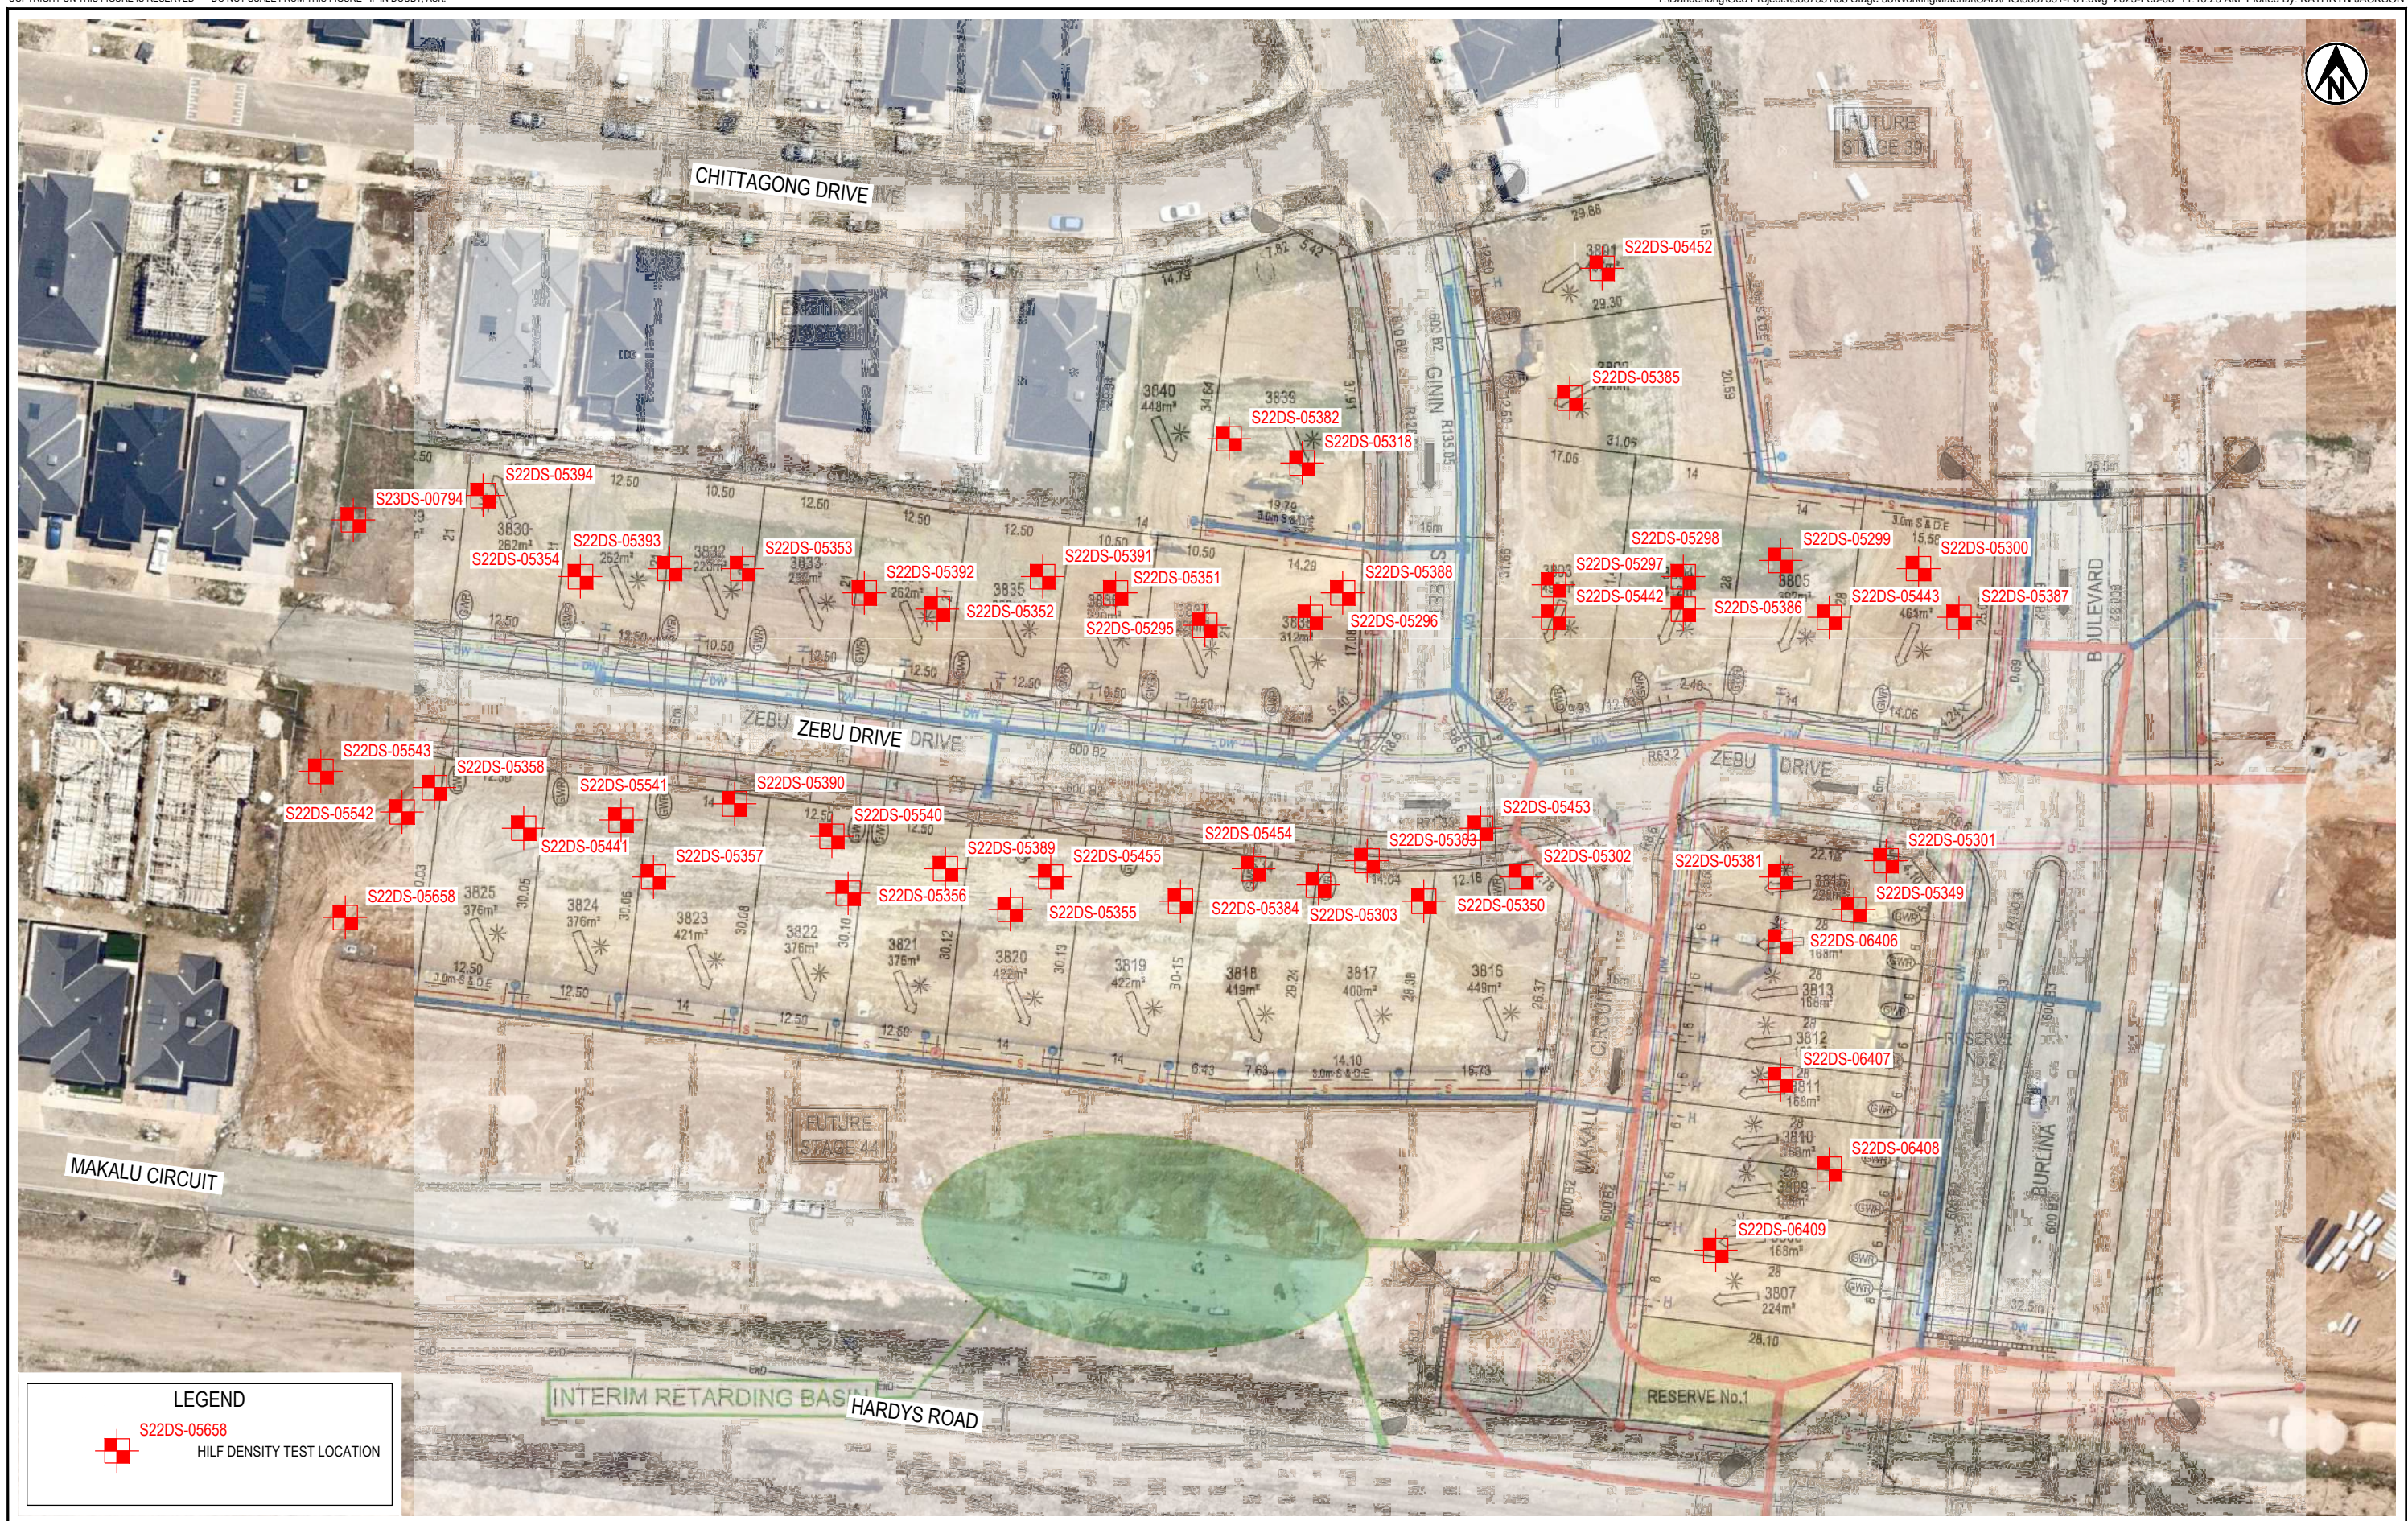
CLIENT	GROSVENOR LODGE PTY LTD
PROJECT	MERIDIAN ESTATE - STAGE 38
TITLE	LEVEL 1 HILF DENSITY TESTING HILF DENSITY TEST LOCATION PLAN
SCALE (A3)	1:750
FIG No.	3807351-F01
REV	1

A site plan showing the field density test locations is provided in Appendix A. A summary of the Hilf density test reports is provided within Appendix B, and the laboratory test reports are provided within Appendix C. The Controlled Fill Certificate is provided within Appendix D.
