REPORT

Level One Inspection and Testing Services

Meridian Estate Stage 2, Clyde North
Lots 201 to 224, 226 to 229, 235 to 238, 241
to 245 and Lot A

Our Ref: 3807351 Stage 2.v1

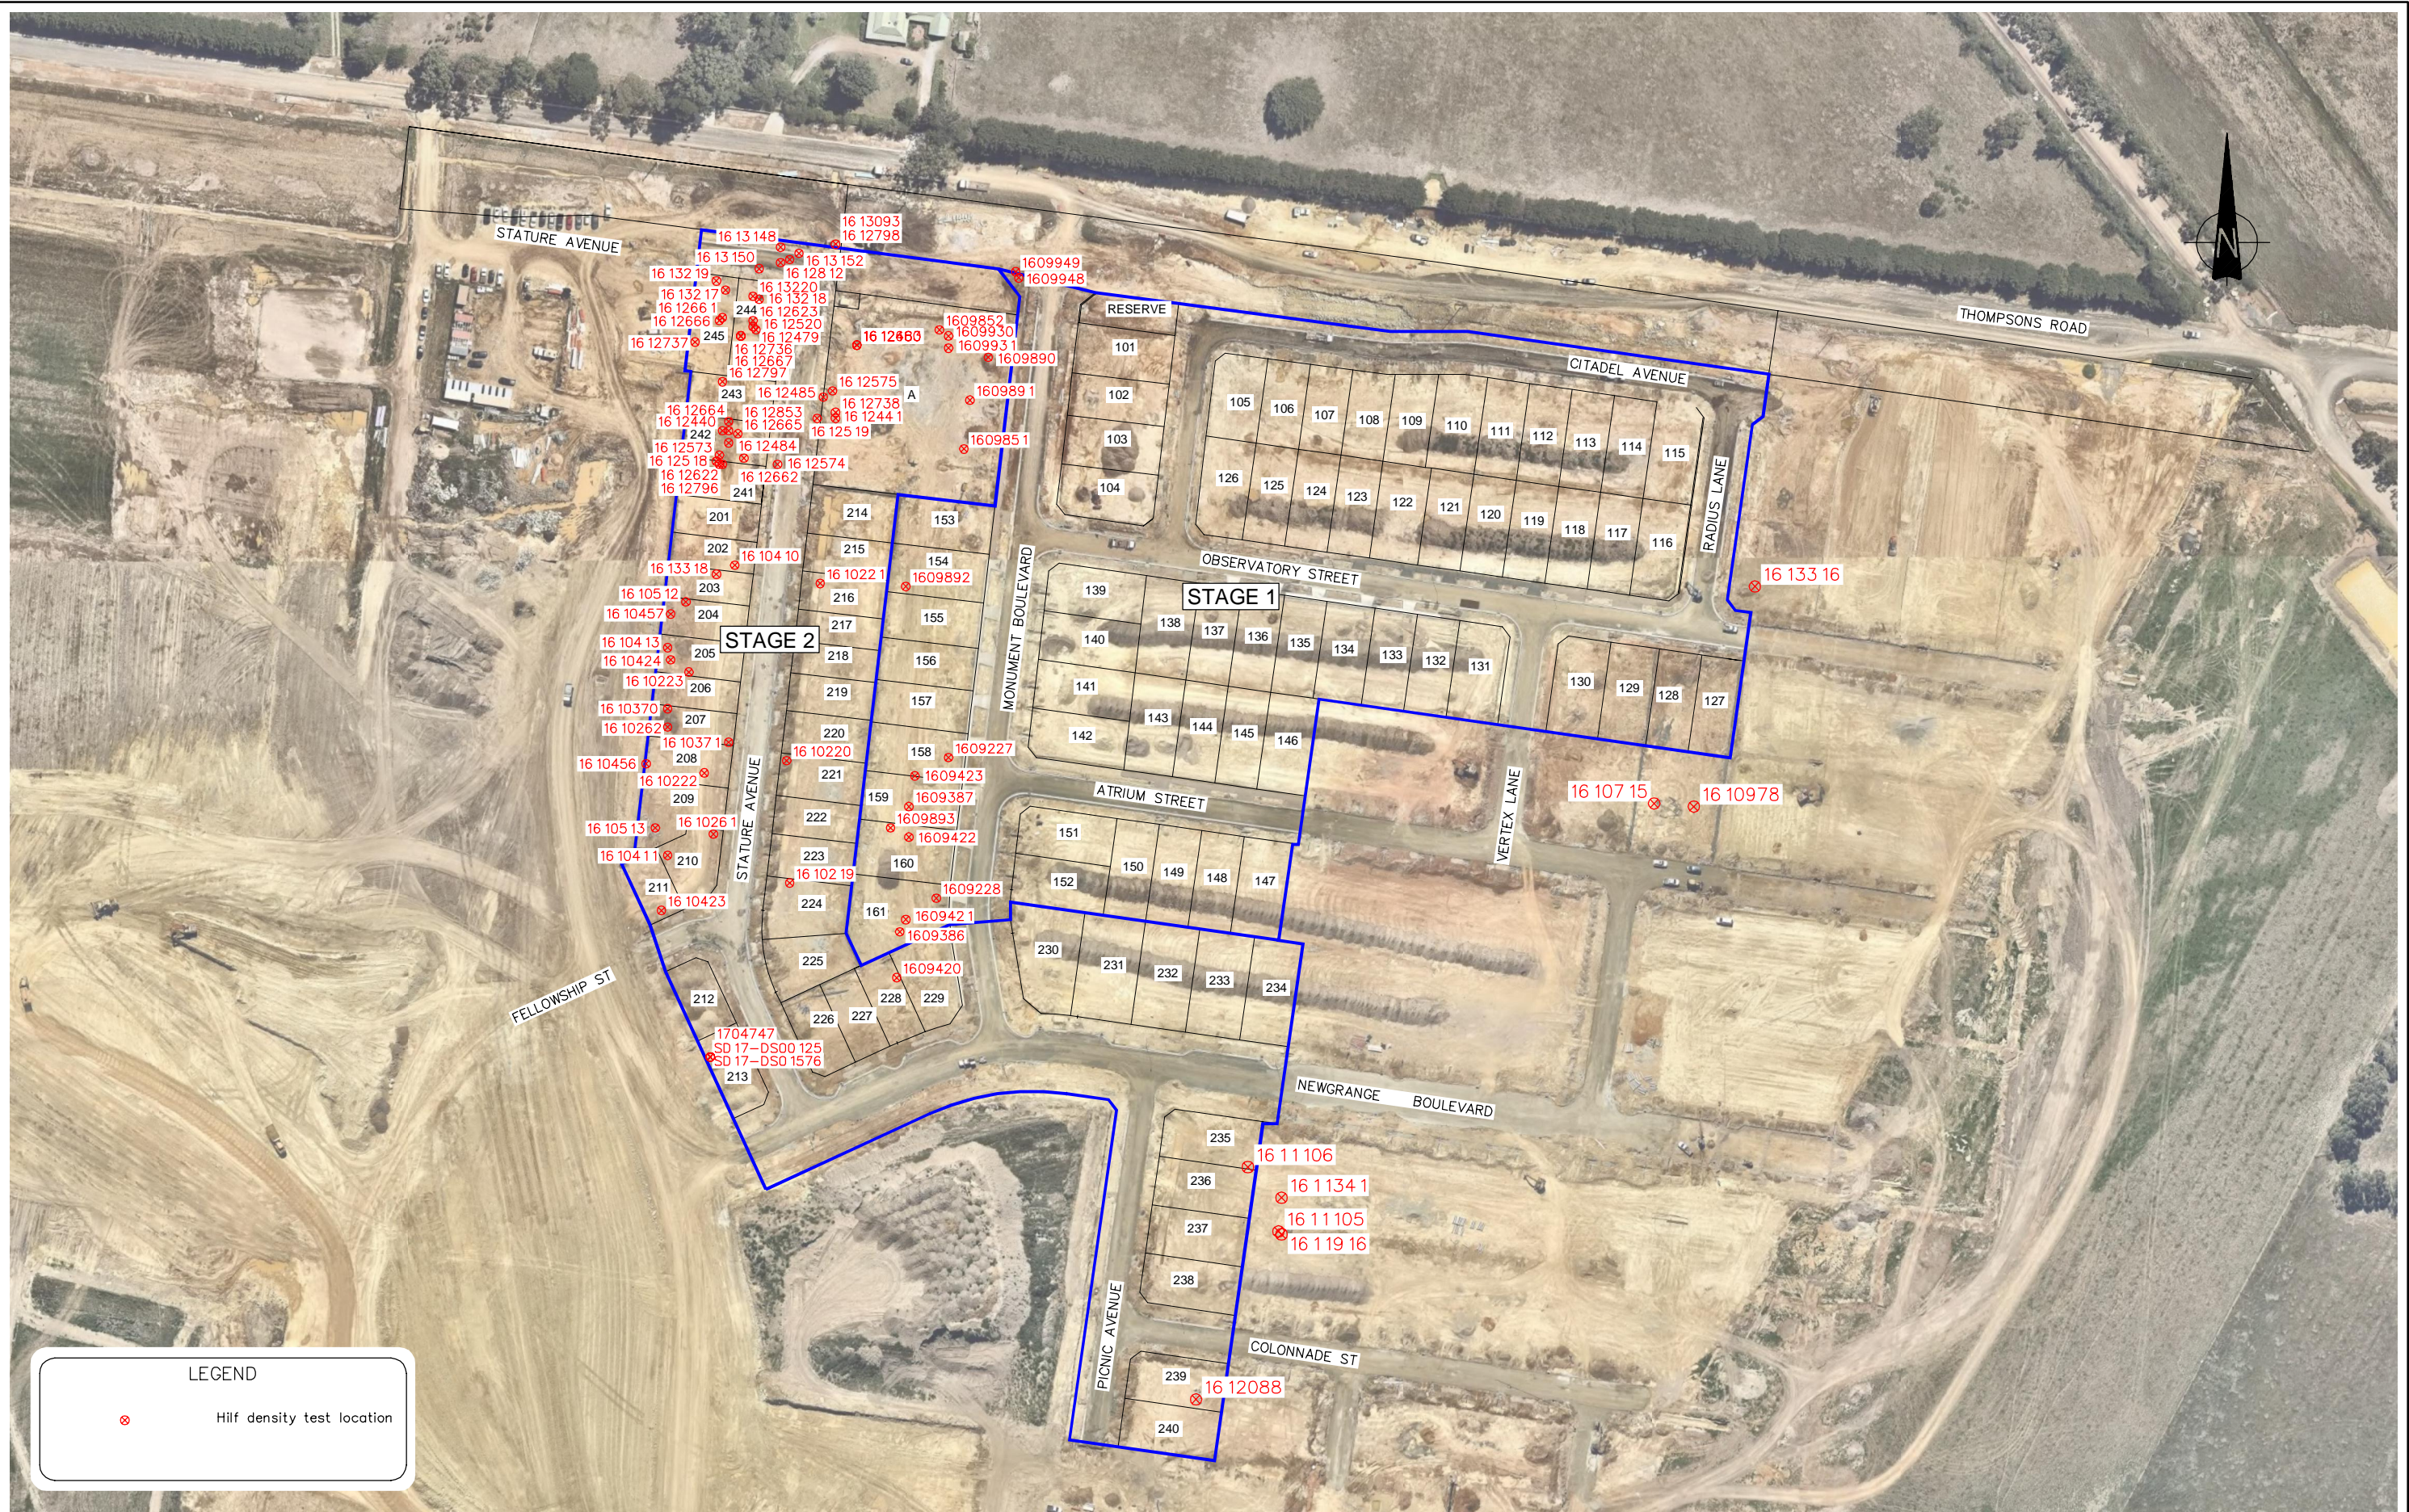
Appendix A: Density test location plan

Field density and moisture content testing was carried out using a calibrated nuclear density gauge in accordance with AS 1289.5.8.1³. The HILF rapid compaction test was used for peak converted wet density determinations in accordance with AS 1289.5.7.1. The test locations were recorded using a handheld GPS unit. A site plan showing the field density and moisture content test locations is provided in Appendix A.
