# **REPORT**

Level One Inspection and Testing Services

Meridian Estate Stage 11, Clyde North, Lots 1111 to 1129

Our Ref: 3807351.011.v2

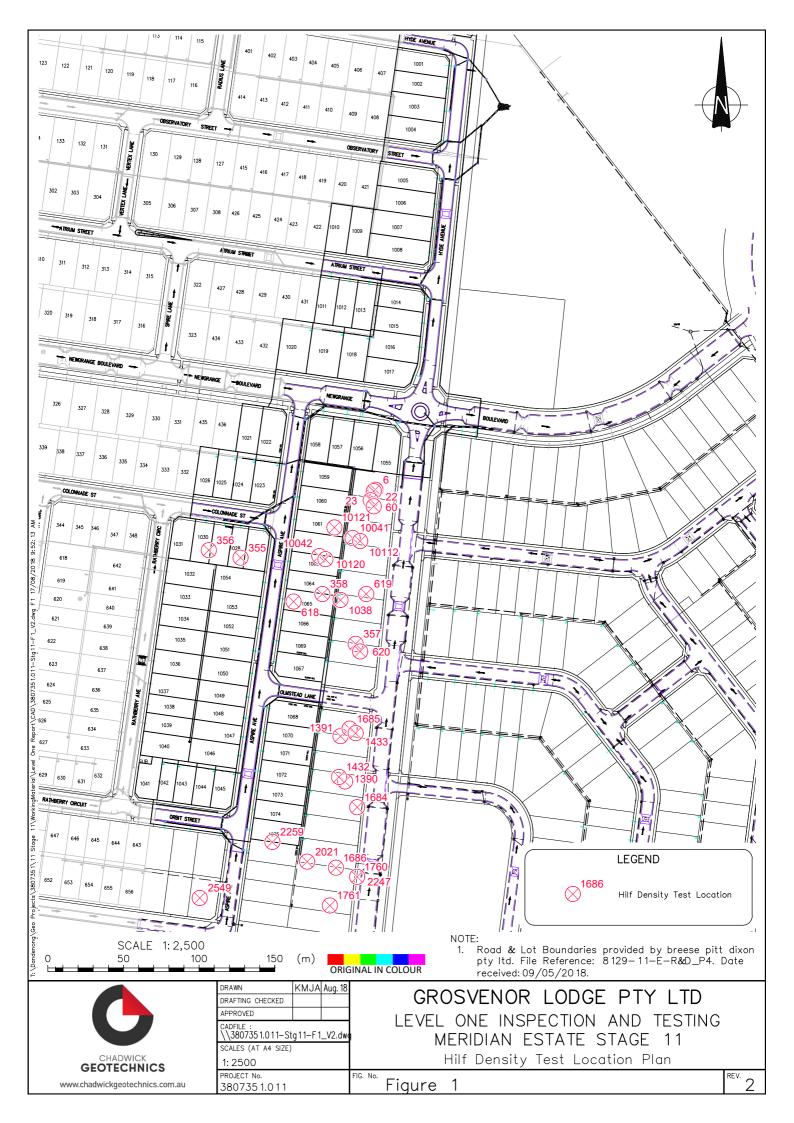
# Appendix A: Density Test Location Plan

Field density and moisture content testing was carried out using a calibrated nuclear density gauge in accordance with AS 1289.5.8.1. The HILF rapid compaction test was used for peak converted wet density determinations in accordance with AS 1289.5.7.1. Test locations were recorded using a handheld GPS unit. A site plan showing the field density test locations is provided in Appendix A.

A total of twenty three (23) tests were performed during the filling process.

The results show that three (3) tests failed to meet the specification requirements for the project. The earthworks contractor was advised of the tests that failed and the fill relevant to those areas

was reworked, reconditioned, re-compacted and subsequently retested. The final results show the tests achieved the specification requirements for the project.
