REPORT

Level One Inspection and Testing Services

Meridian Estate Stage 13, Lot's 1301, 1302, 1339 and 1340

Our Ref: 3807351.013.v1

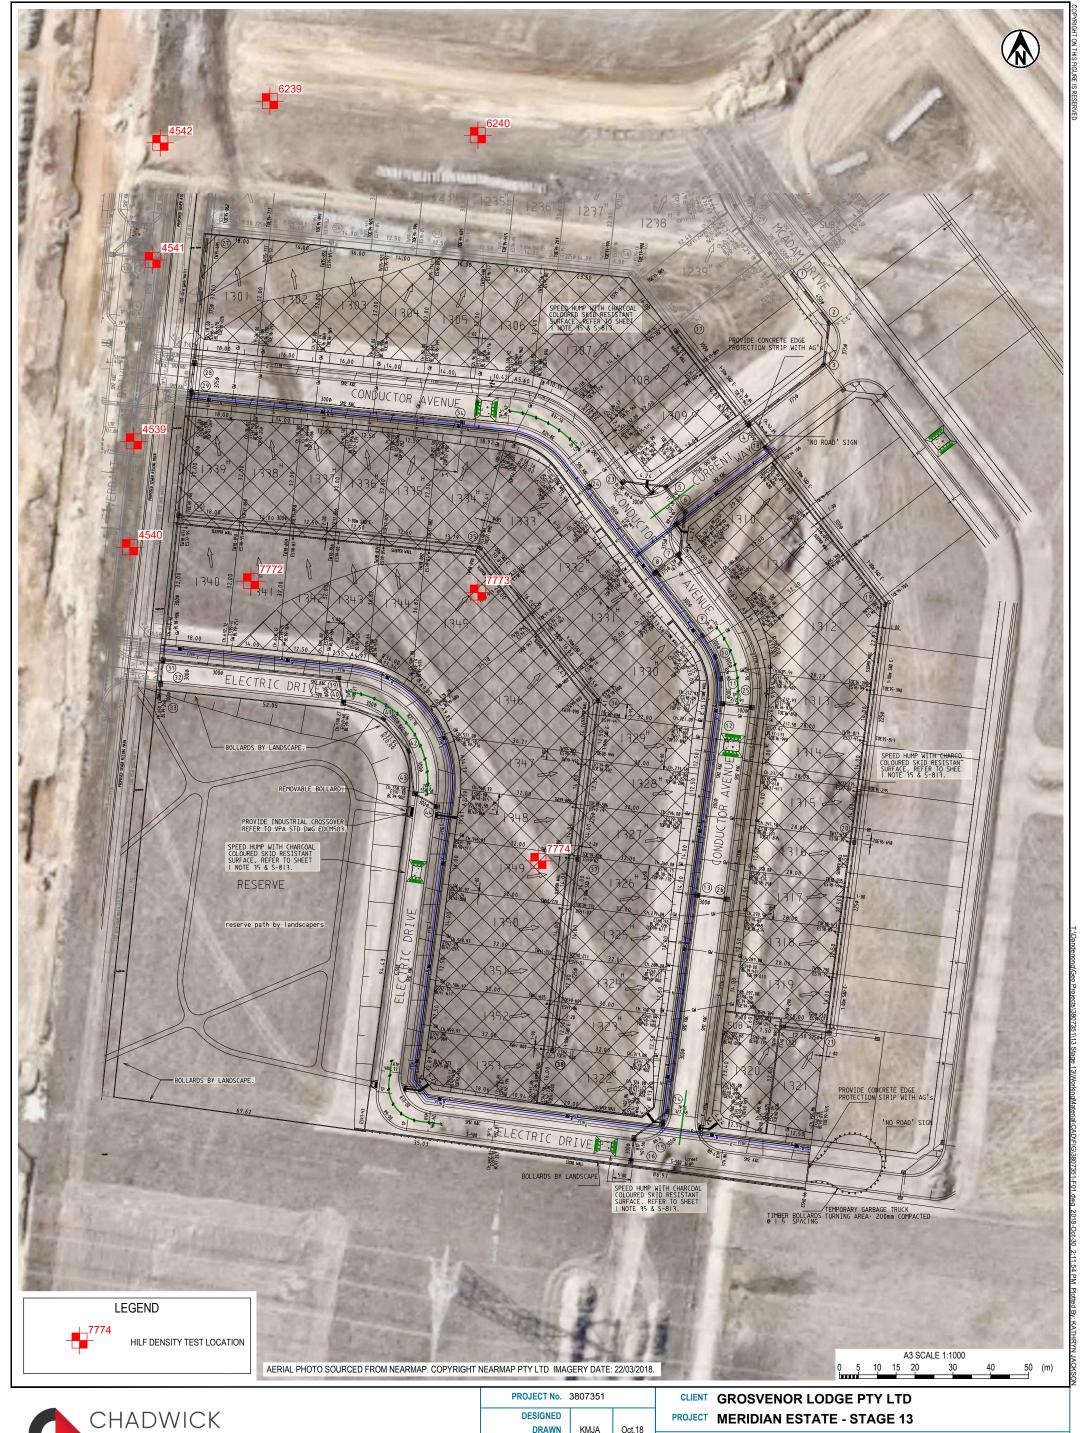
Appendix A: Density Test Location Plan

Field density and moisture content testing was carried out using a calibrated nuclear density gauge in accordance with AS 1289.5.8.1. The HILF rapid compaction test was used for peak converted wet density determinations in accordance with AS 1289.5.7.1. Test locations were recorded using a handheld GPS unit. A site plan showing the field density test locations is provided in Appendix A.

A total of six (6) tests were performed during the filling process.

The results show that all tests achieved the specification requirements for the project.
