Level One Inspection and Testing Services

Meridian Estate Stage 15, Lot's 1501 to 1533 and 1542 to 1554

Grosvenor Lodge Pty Ltd

February 2019

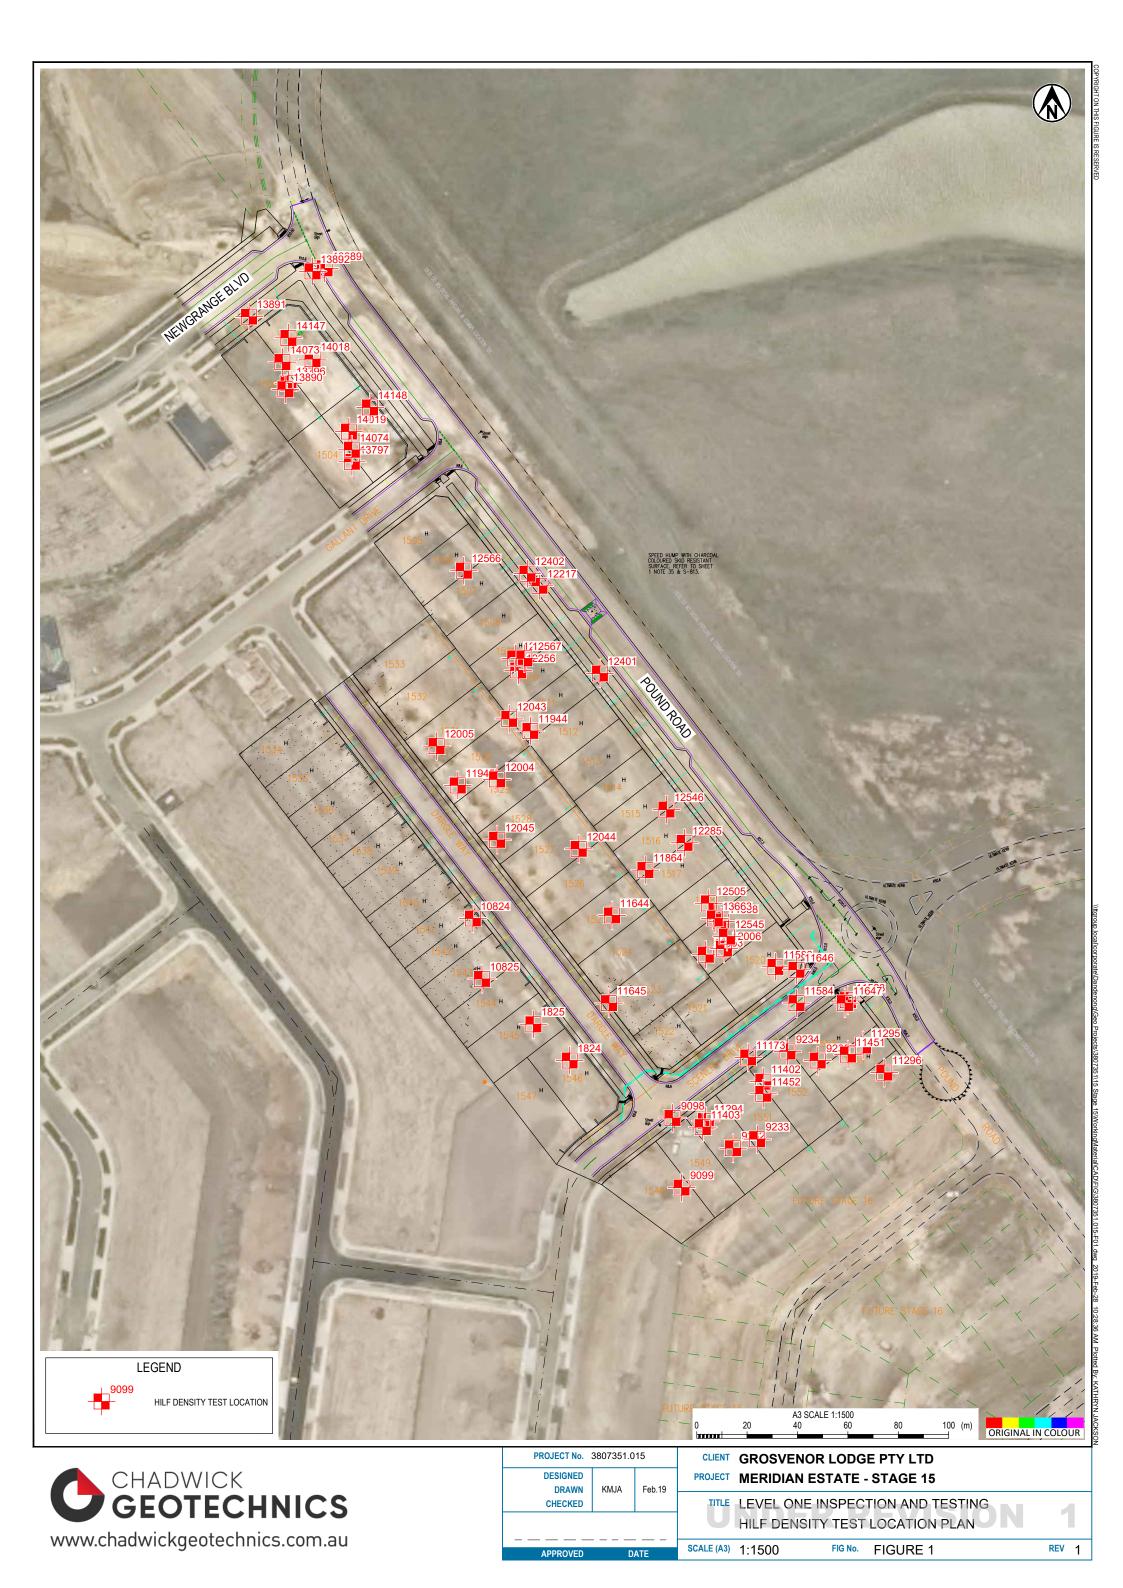
Appendix A: Density Test Location Plan

Field density and moisture content testing was carried out using a calibrated nuclear density gauge in accordance with AS 1289.5.8.1. The HILF rapid compaction test was used for peak converted wet density determinations in accordance with AS 1289.5.7.1. Test locations were recorded using a handheld GPS unit. A site plan showing the field density test locations is provided in Appendix A.

The results show that six (6) tests failed to meet the specification requirements for the project. The earthworks contractor was advised of the tests that failed and the fill relevant to those areas was reworked, reconditioned, re-compacted and subsequently retested. The final results show the tests achieved the specification requirements for the project.
