## **Level One Inspection and Testing Services**

**Meridian Estate Stage 6, Clyde North  
Lot's 601 to 609 and 618 to 656**

**Our Ref: 3807351 Stage 6.v1**

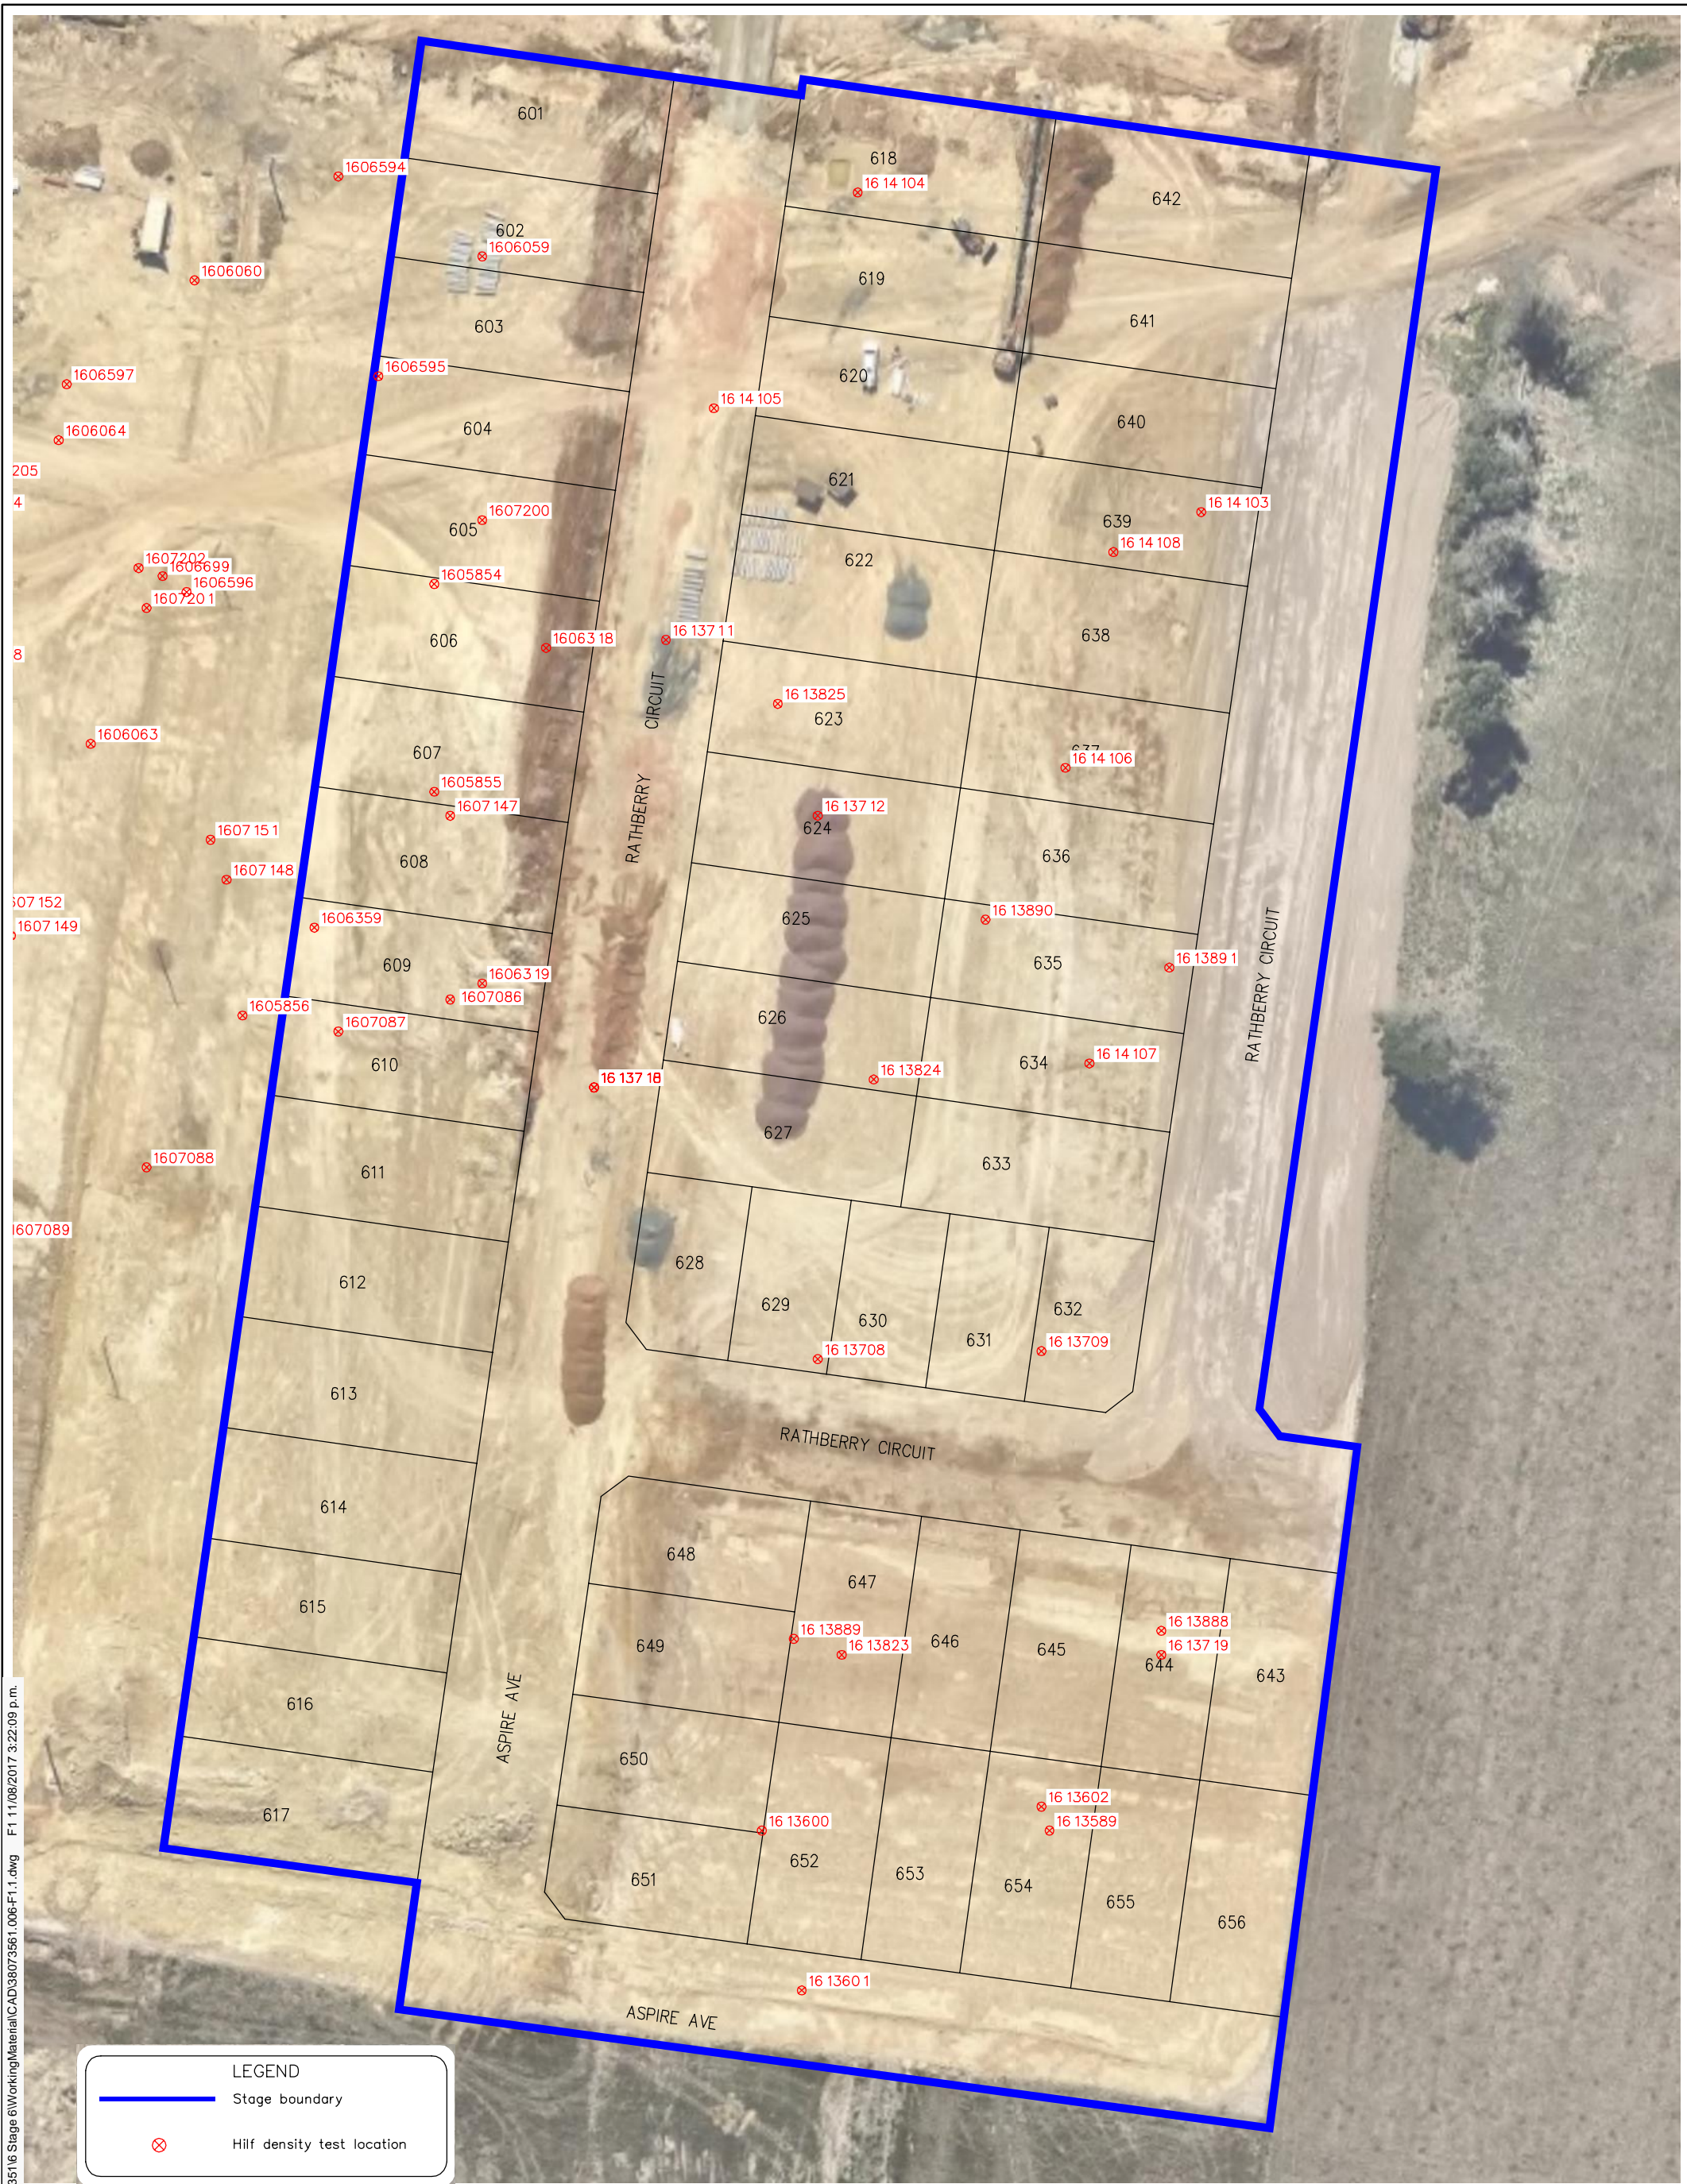
## **Appendix A: Density test location plan**

Field density and moisture content testing was carried out using a calibrated nuclear density gauge in accordance with AS 1289.5.8.1<sup>3</sup>. The HILF rapid compaction test was used for peak converted wet density determinations in accordance with AS 1289.5.7.1. The test locations were recorded using a handheld GPS unit. A site plan showing the field density and moisture content test locations is provided in **Appendix A**.

The testing results show that one test failed to meet the specified density limit for the project. The earthworks contractor was advised of the test that failed and the fill relevant to the area was reworked, reconditioned, re-compacted and subsequently retested.
