Level 1 Geotechnical Testing and Inspection Authority Services

**Meridian Central Estate Stage 42
Clyde North
Lots 4201 to 4234**

Our Ref: 3807351.042.v1

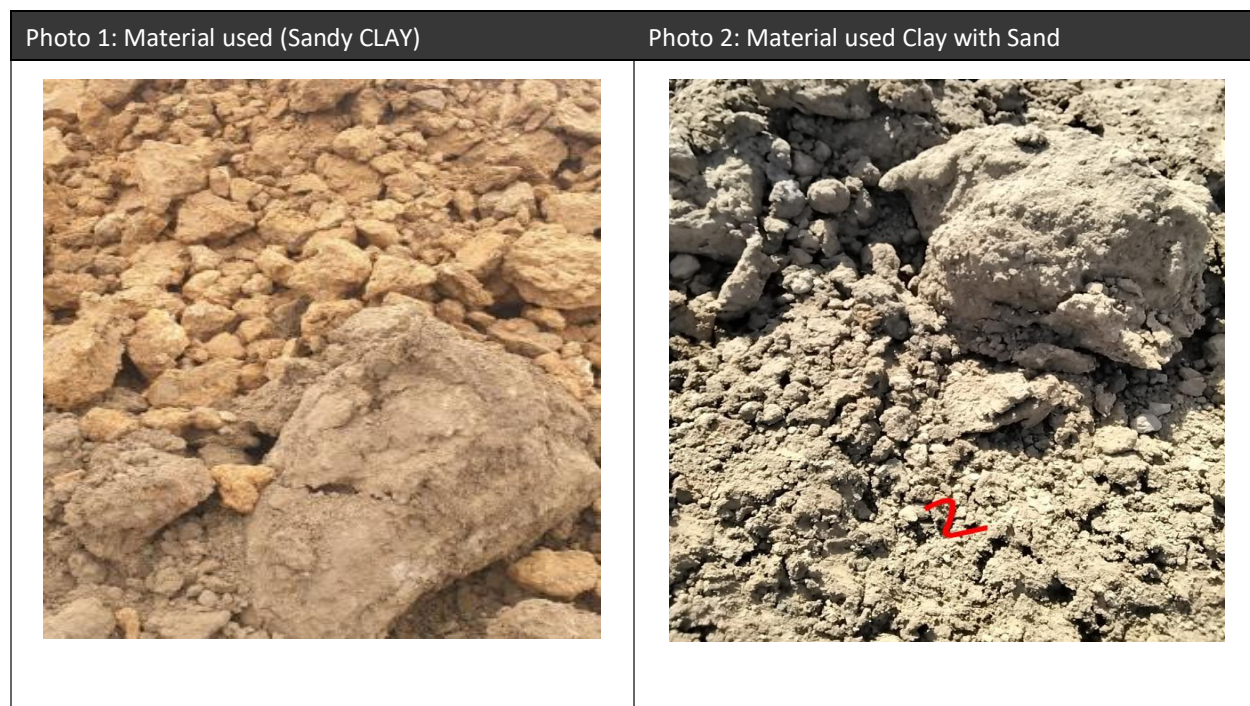
Figure 3.1: Photographs of the material used on site

Any observed organic or deleterious matter including any oversize cobbles or boulders were removed from the tested areas during the fill placement.

Below are photographs of typical materials used during construction.

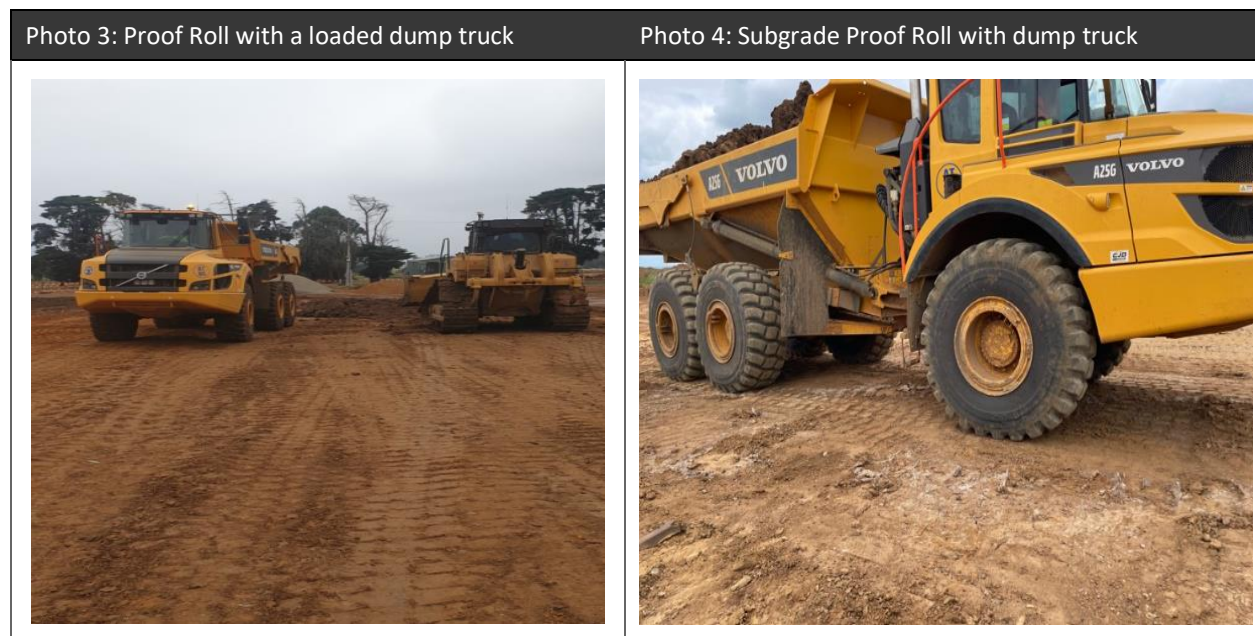
Figure 3.2: Subgrade assessment photographs

The subgrade inspections were performed in accordance with the Level 1 guidelines presented in AS 3798–2007 Section 5.5. No soft spots or deflections were encountered during the inspections and the area was found to be firm and free of vegetation and other deleterious material.

Below are photographs of the subgrade assessment phase at the project.
