Level 1 Geotechnical Testing and Inspection Authority Services

**Meridian Central Estate Stage 43
Lots 4301 to 4340**

Our Ref: 3807351.043.v1

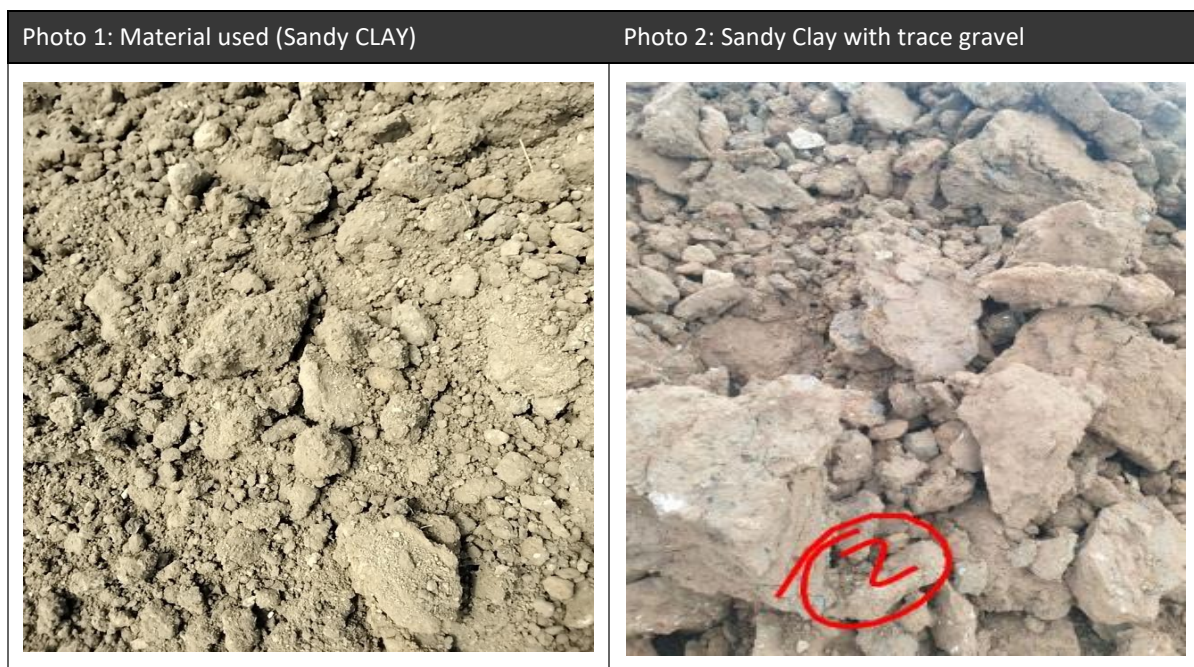
Photograph 4.1: Photographs of the material used on site

Any observed organic or deleterious matter including any oversize cobbles or boulders were removed from the tested areas during the fill placement.

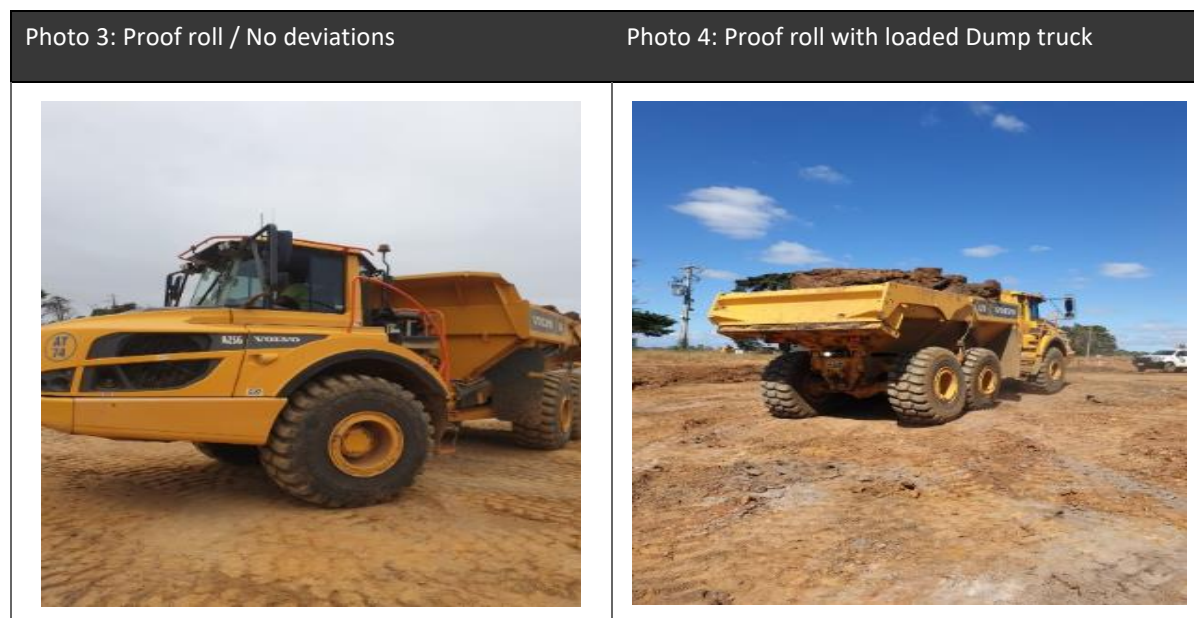
Photograph 4.2: Subgrade assessment photographs

The subgrade inspections were performed in accordance with the Level 1 guidelines presented in AS 3798–2007 Section 5.5. No soft spots or deflections were encountered during the inspections and the area was found to be firm and free of vegetation and other deleterious material.

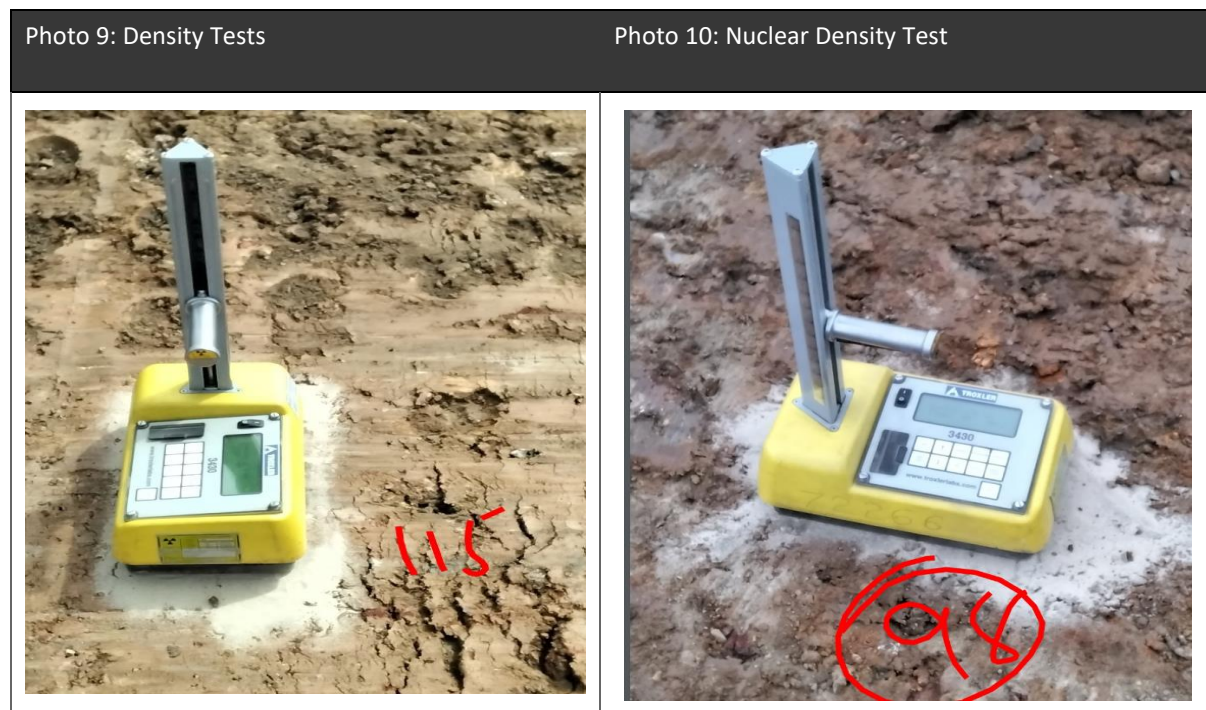
Photograph 4.4: Density Testing photographs

One hundred and ten (110) tests were performed during the filling process. Fourteen (14) of the tests did not achieve the required density and or moisture ratio initially. The failed areas were reworked and retested accordingly. The retests returned passing density and moisture test results.
