# **REPORT**

## **Level 1 Geotechnical Testing and Inspection Authority Services**

**Meridian Central Estate Stage 45  
Lots 4501 to 4505 and 4519 to 4548**

**Our Ref: 3807351.045.v1**

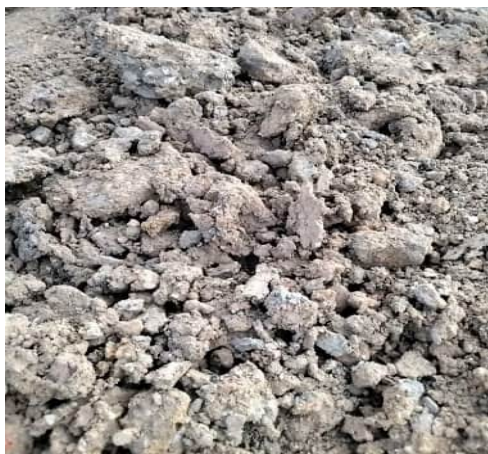
**Photo 1: Material Used (Silty Clay)**

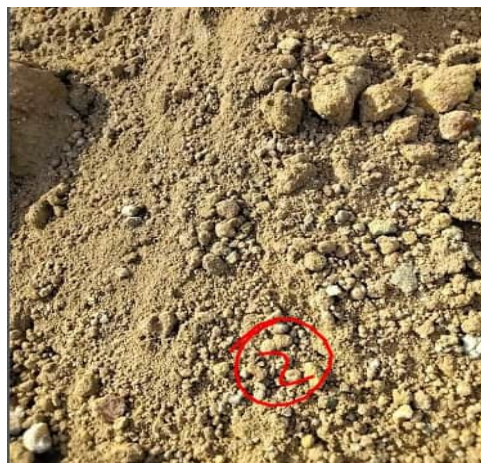
**Photo 2: Material Used (Sandy Clay)**

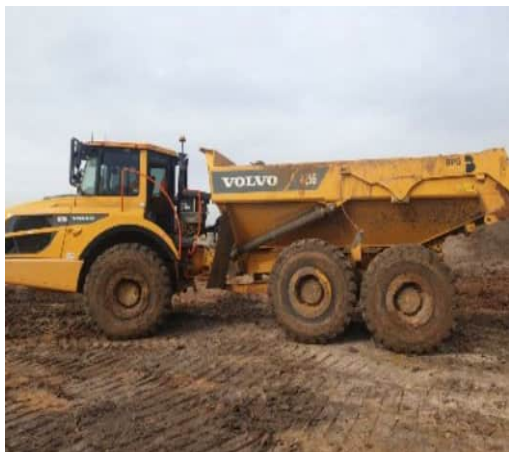
The subgrade inspections were performed in accordance with the Level 1 guidelines presented in AS 3798–2007 Section 5.5. No soft spots or deflections were encountered during the inspections and the area was found to be firm and free of vegetation and other deleterious material.

**Photo 3: Proof Roll with Dump truck**

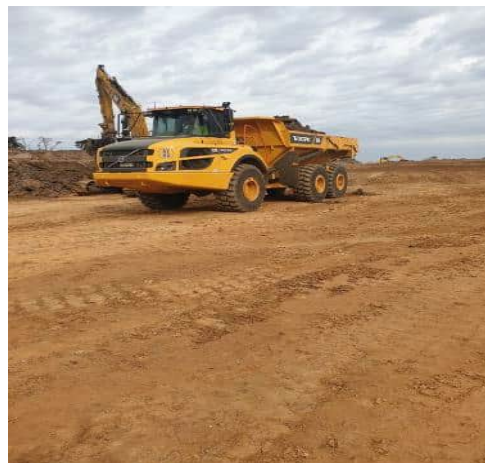
**Photo 4: Typical surface**

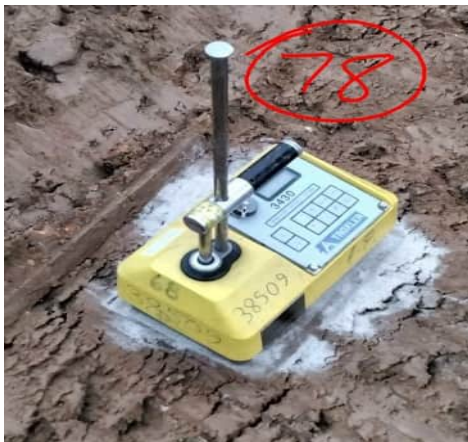
Two Hundred and Seventy Six (276) tests were performed during the filling process. Seventeen (17) of the tests did not achieve the required density and or moisture ratio initially. The failed areas were reworked and retested accordingly. The retests returned passing density and moisture test results.

Photo 9: Nuclear Density Test

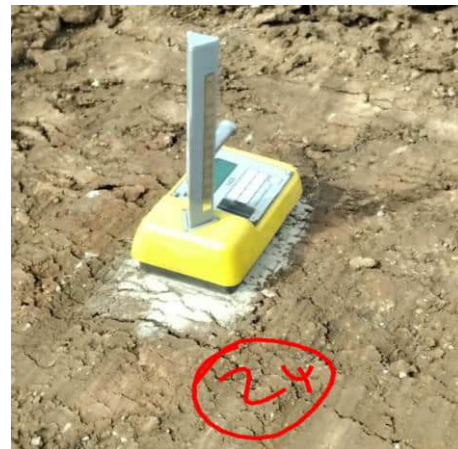
Photo 10: Density Test with sand
