## **Level 1 Geotechnical Testing and Inspection Authority Services**

**Meridian Green Estate Clyde North  
Stage 46**

**Lots 4601 to 4611 and 4650 to Lot 4664**

**Our Ref: 1091936.046.v1**

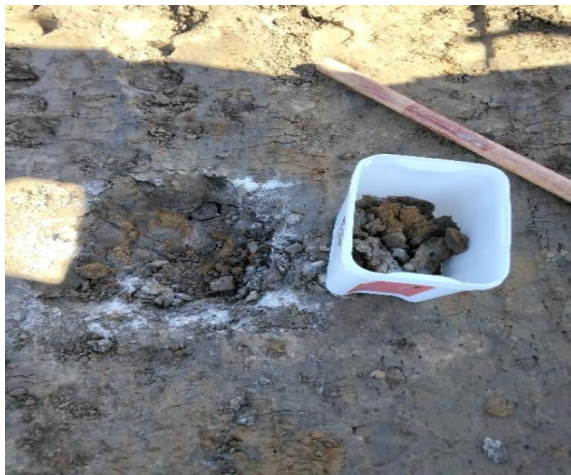
*Photograph 1: Typical on-site clay material*

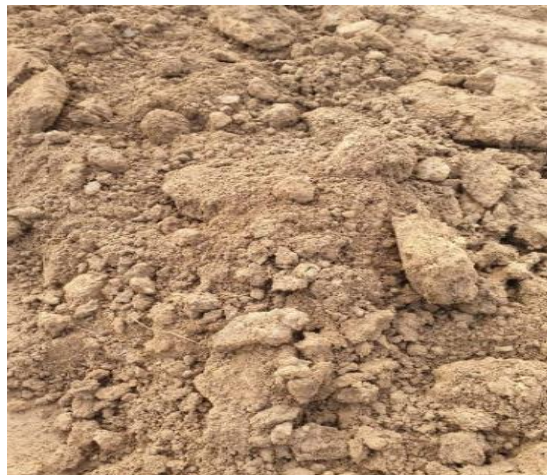
*Photograph 2: Silty Brown Clay*

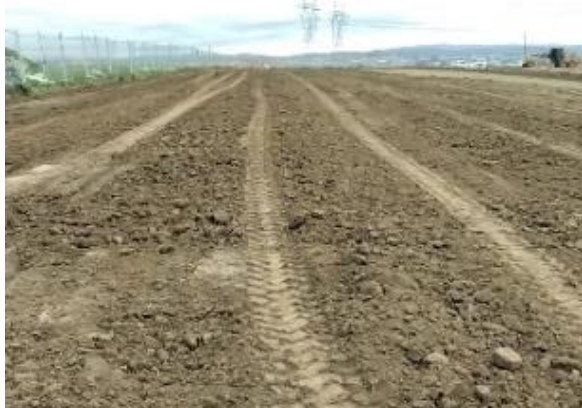
The subgrade inspections were performed in accordance with the Level 1 guidelines presented in AS 3798–2007 Section 5.5. No soft spots or deflections were encountered during the inspections and the area was found to be firm and free of vegetation and other deleterious material.

*Photograph 3: Typical subgrade surface*

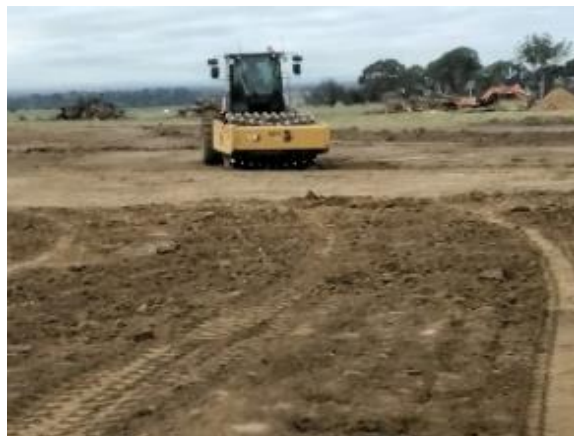
*Photograph 4: Subgrade*

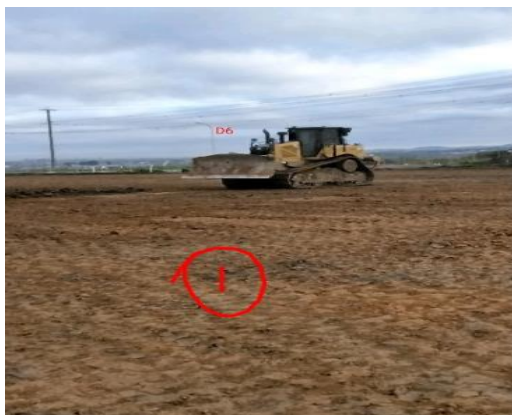
*Photograph 5:* D6 Dozer used during filling.

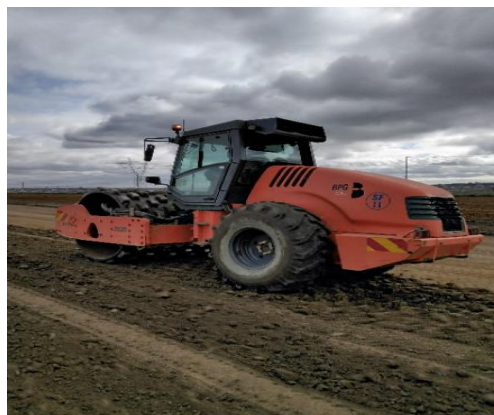
*Photograph 6:* Pad foot compacting clay

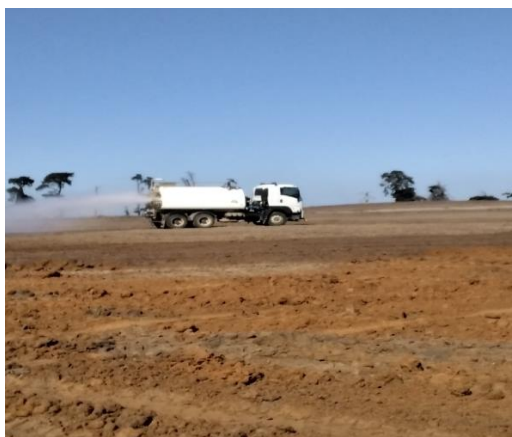
*Photograph 7:* Water cart for moisture conditioning

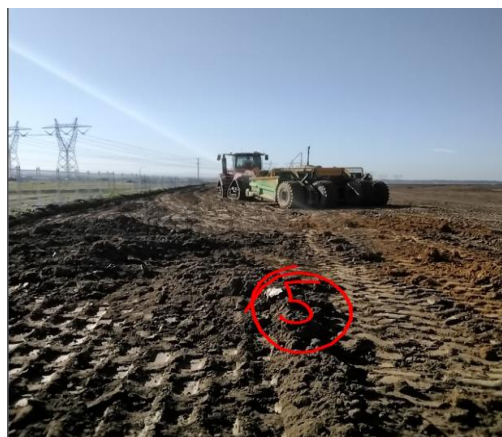
*Photograph 8:* Scraper placing material

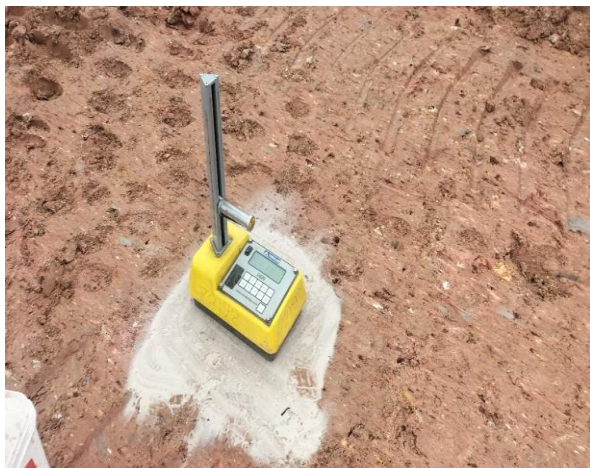
*Photo 9: Field density/moisture test*

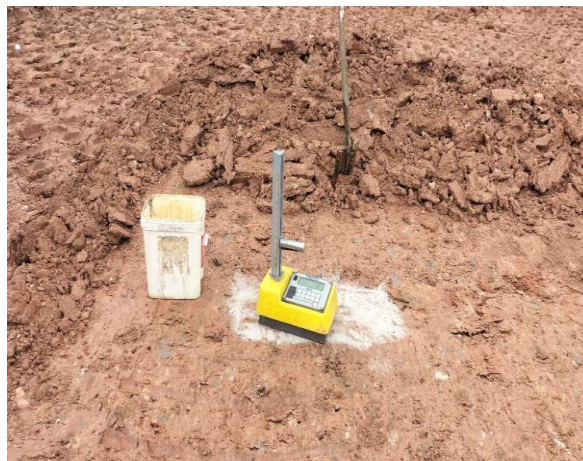
*Photo 10: Field density/moisture test*
