Level 1 Geotechnical Testing and Inspection Authority Services

**Meridian Green Estate Clyde North
Stage 47**

**Lots 4701 to 4712 and 4715, 4716 and 4724
to 4747**

16 February 2024

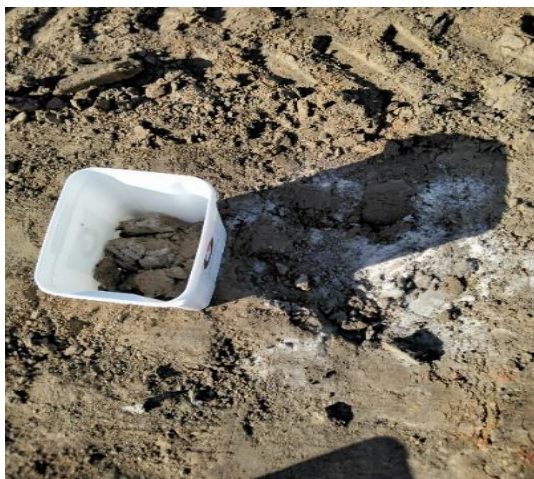
Photograph 1: Typical on-site clay material

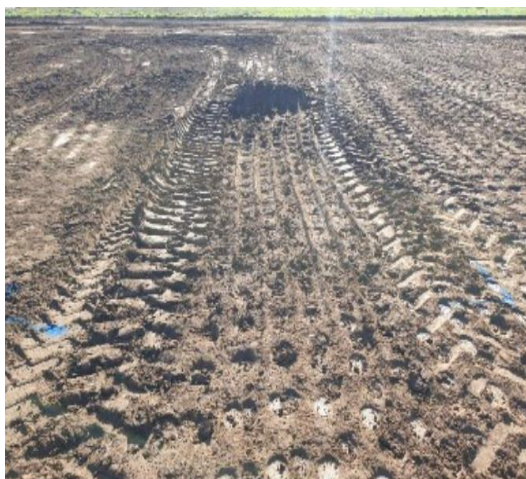
Photograph 2: Silty Brown Clay

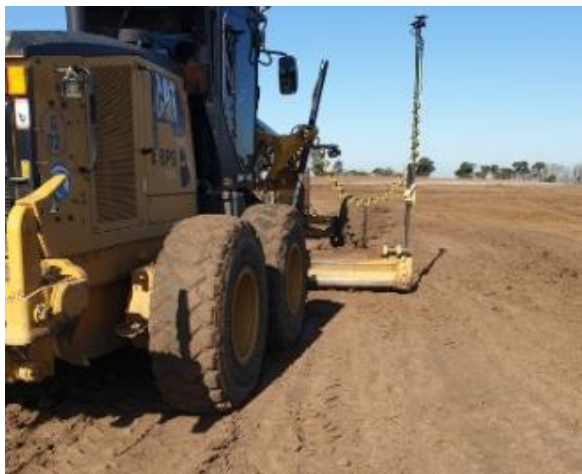
Photograph 3: Typical subgrade surface

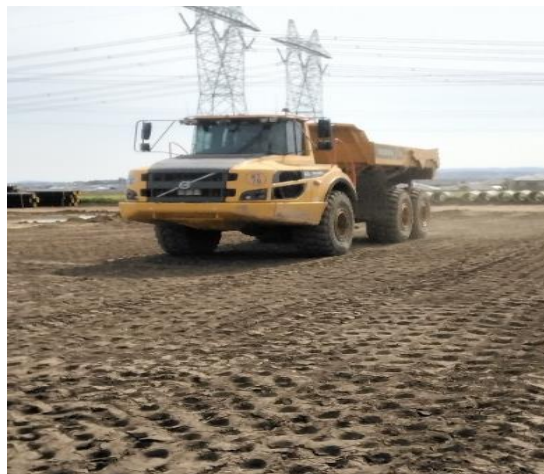
The subgrade inspections were performed in accordance with the Level 1 guidelines presented in AS 3798–2007 Section 5.5. No soft spots or deflections were encountered during the inspections and the area was found to be firm and free of vegetation and other deleterious material.

Photograph 4: Proof roll of the subgrade

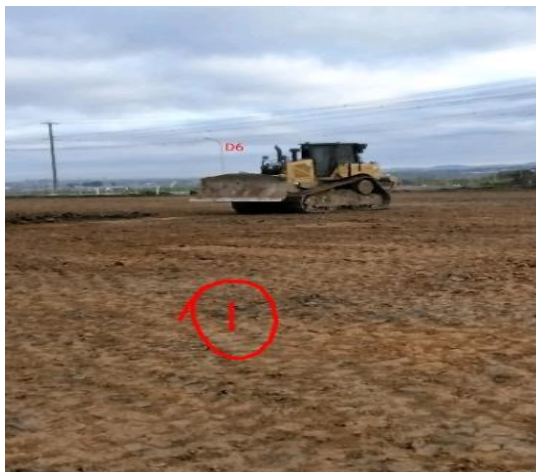
Photograph 5: D6 Dozer used during filling.

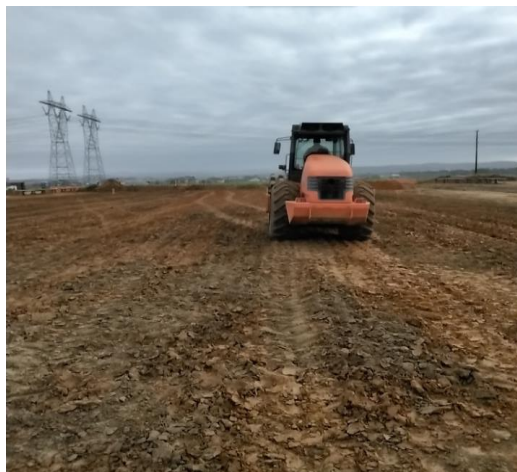
Photograph 6: Pad foot compacting clay

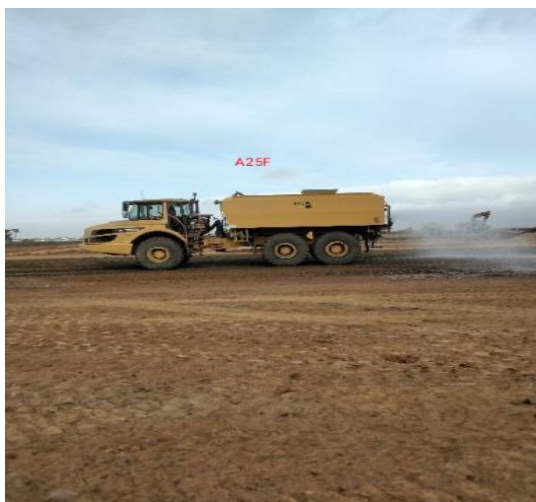
Photograph 7: Water cart used for moisture conditioning

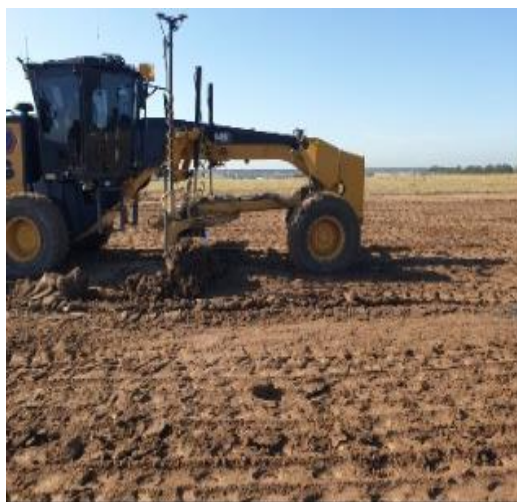
Photograph 8: Grader spreading material

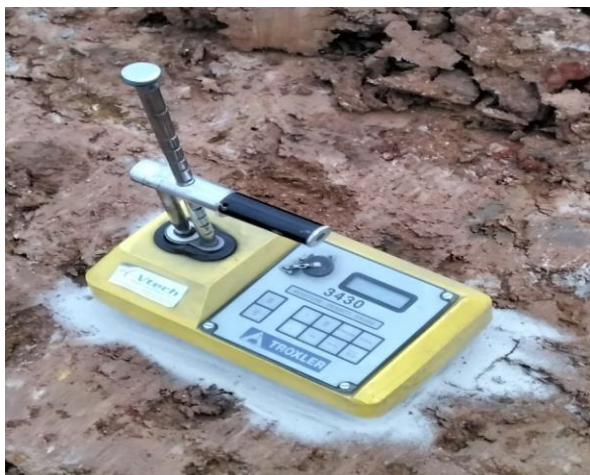
Photo 9: Field density/moisture test

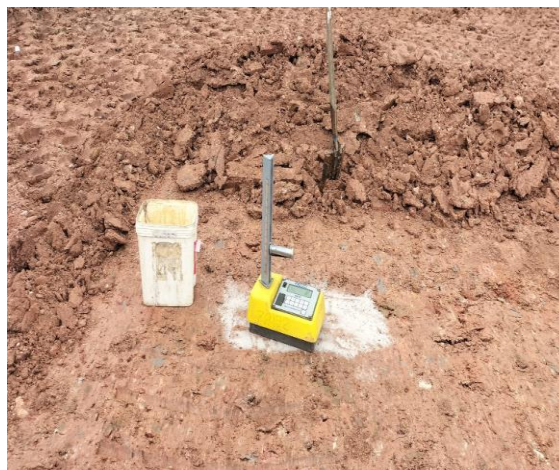
Photo 10: Field density/moisture test
