## **Level 1 Geotechnical Inspection and Testing Authority Services**

**Meridian Green Estate Clyde North  
Stage 49**

**Lots 4901 to 4912, 4924 to 4926 and 4934 to  
Lot 4945**

**Our Ref: 1091936.049.v1**

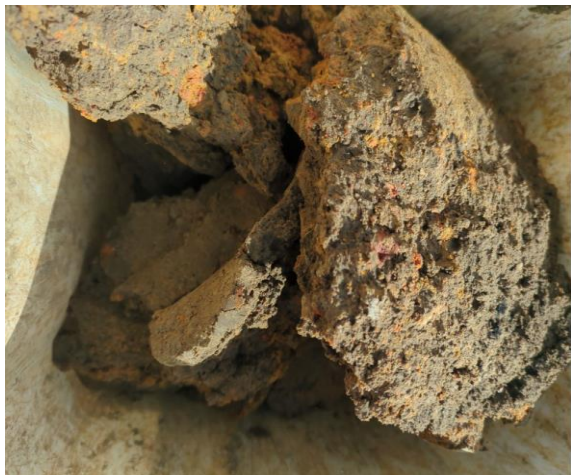
*Photograph 1: Typical on-site clay material*

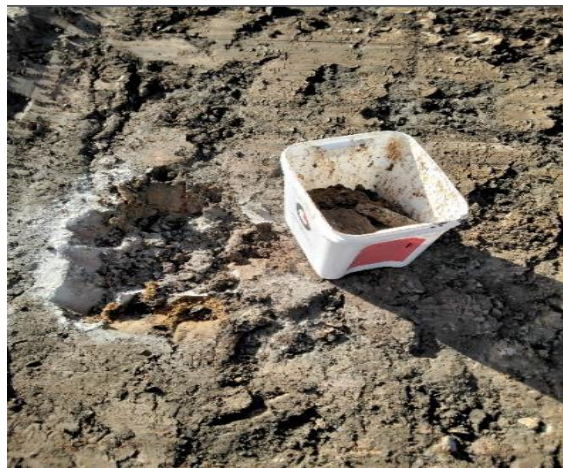
*Photograph 2: Silty Mottled Orange Brown Clay*

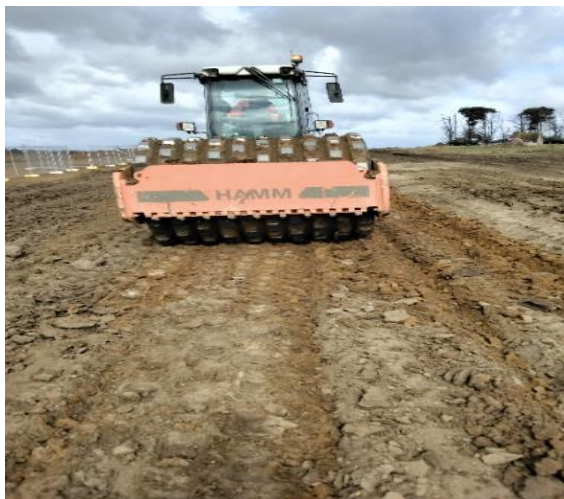
The subgrade inspections were performed in accordance with the Level 1 guidelines presented in AS 3798–2007 Section 5.5. No soft spots or deflections were encountered during the inspections and the area was found to be firm and free of vegetation and other deleterious material.

*Photograph 3: Proof roll with Pad foot*

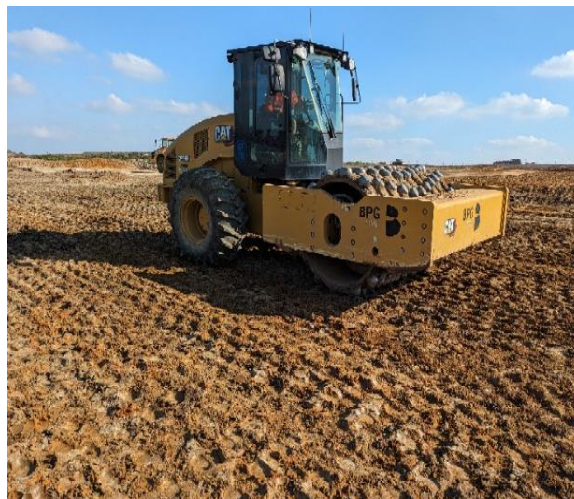
*Photograph 4: Subgrade assessment with 15 Tonne Pad foot Roller*

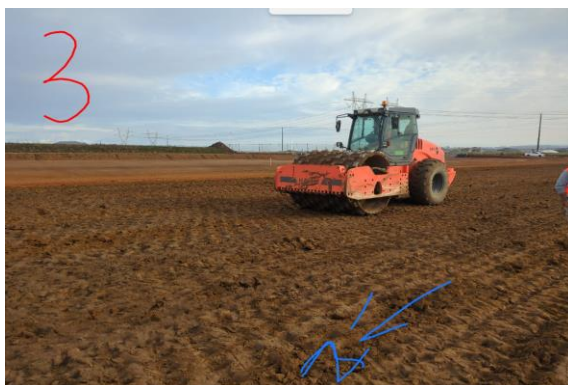
*Photograph 5: Pad foot Roller compacting.*

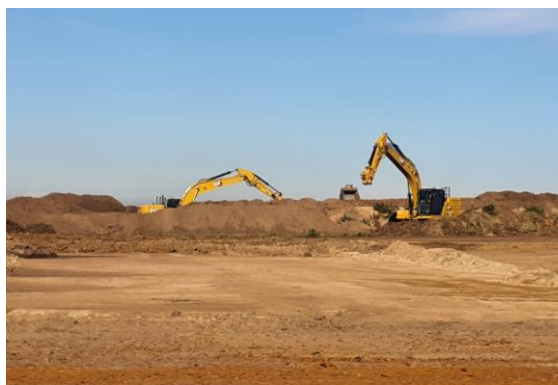
*Photograph 6: Excavator placing fill*

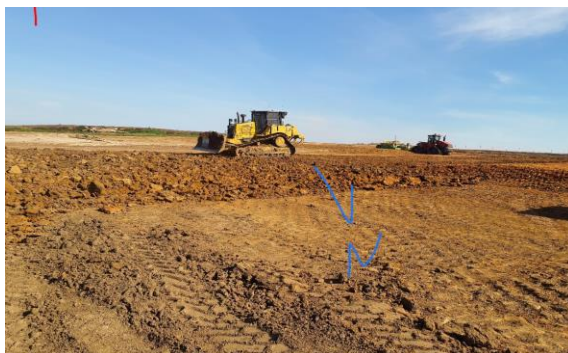
*Photograph 7: Bulldozer.*

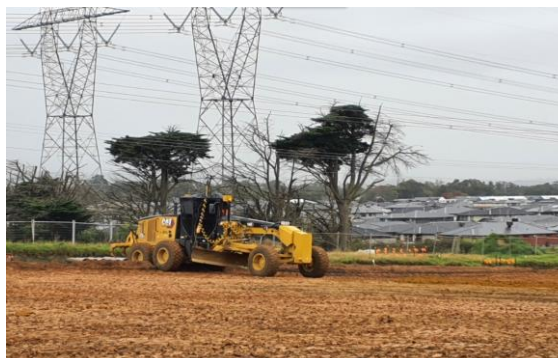
*Photograph 8: Grader*

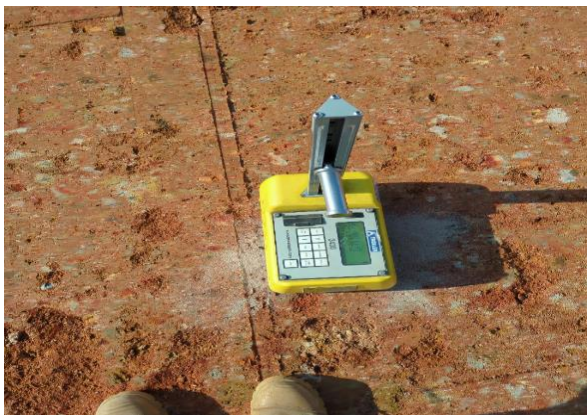
*Photo 9: Field density/moisture test*

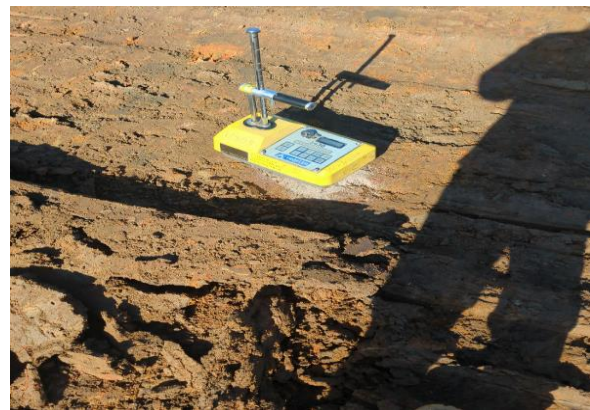
*Photo 10: Field density/moisture test*
