# REPORT

## Level One Inspection and Testing Services

Meridian Estate Stage 21, Lots 2101 to 2136

Our Ref: 3807351.021.v1

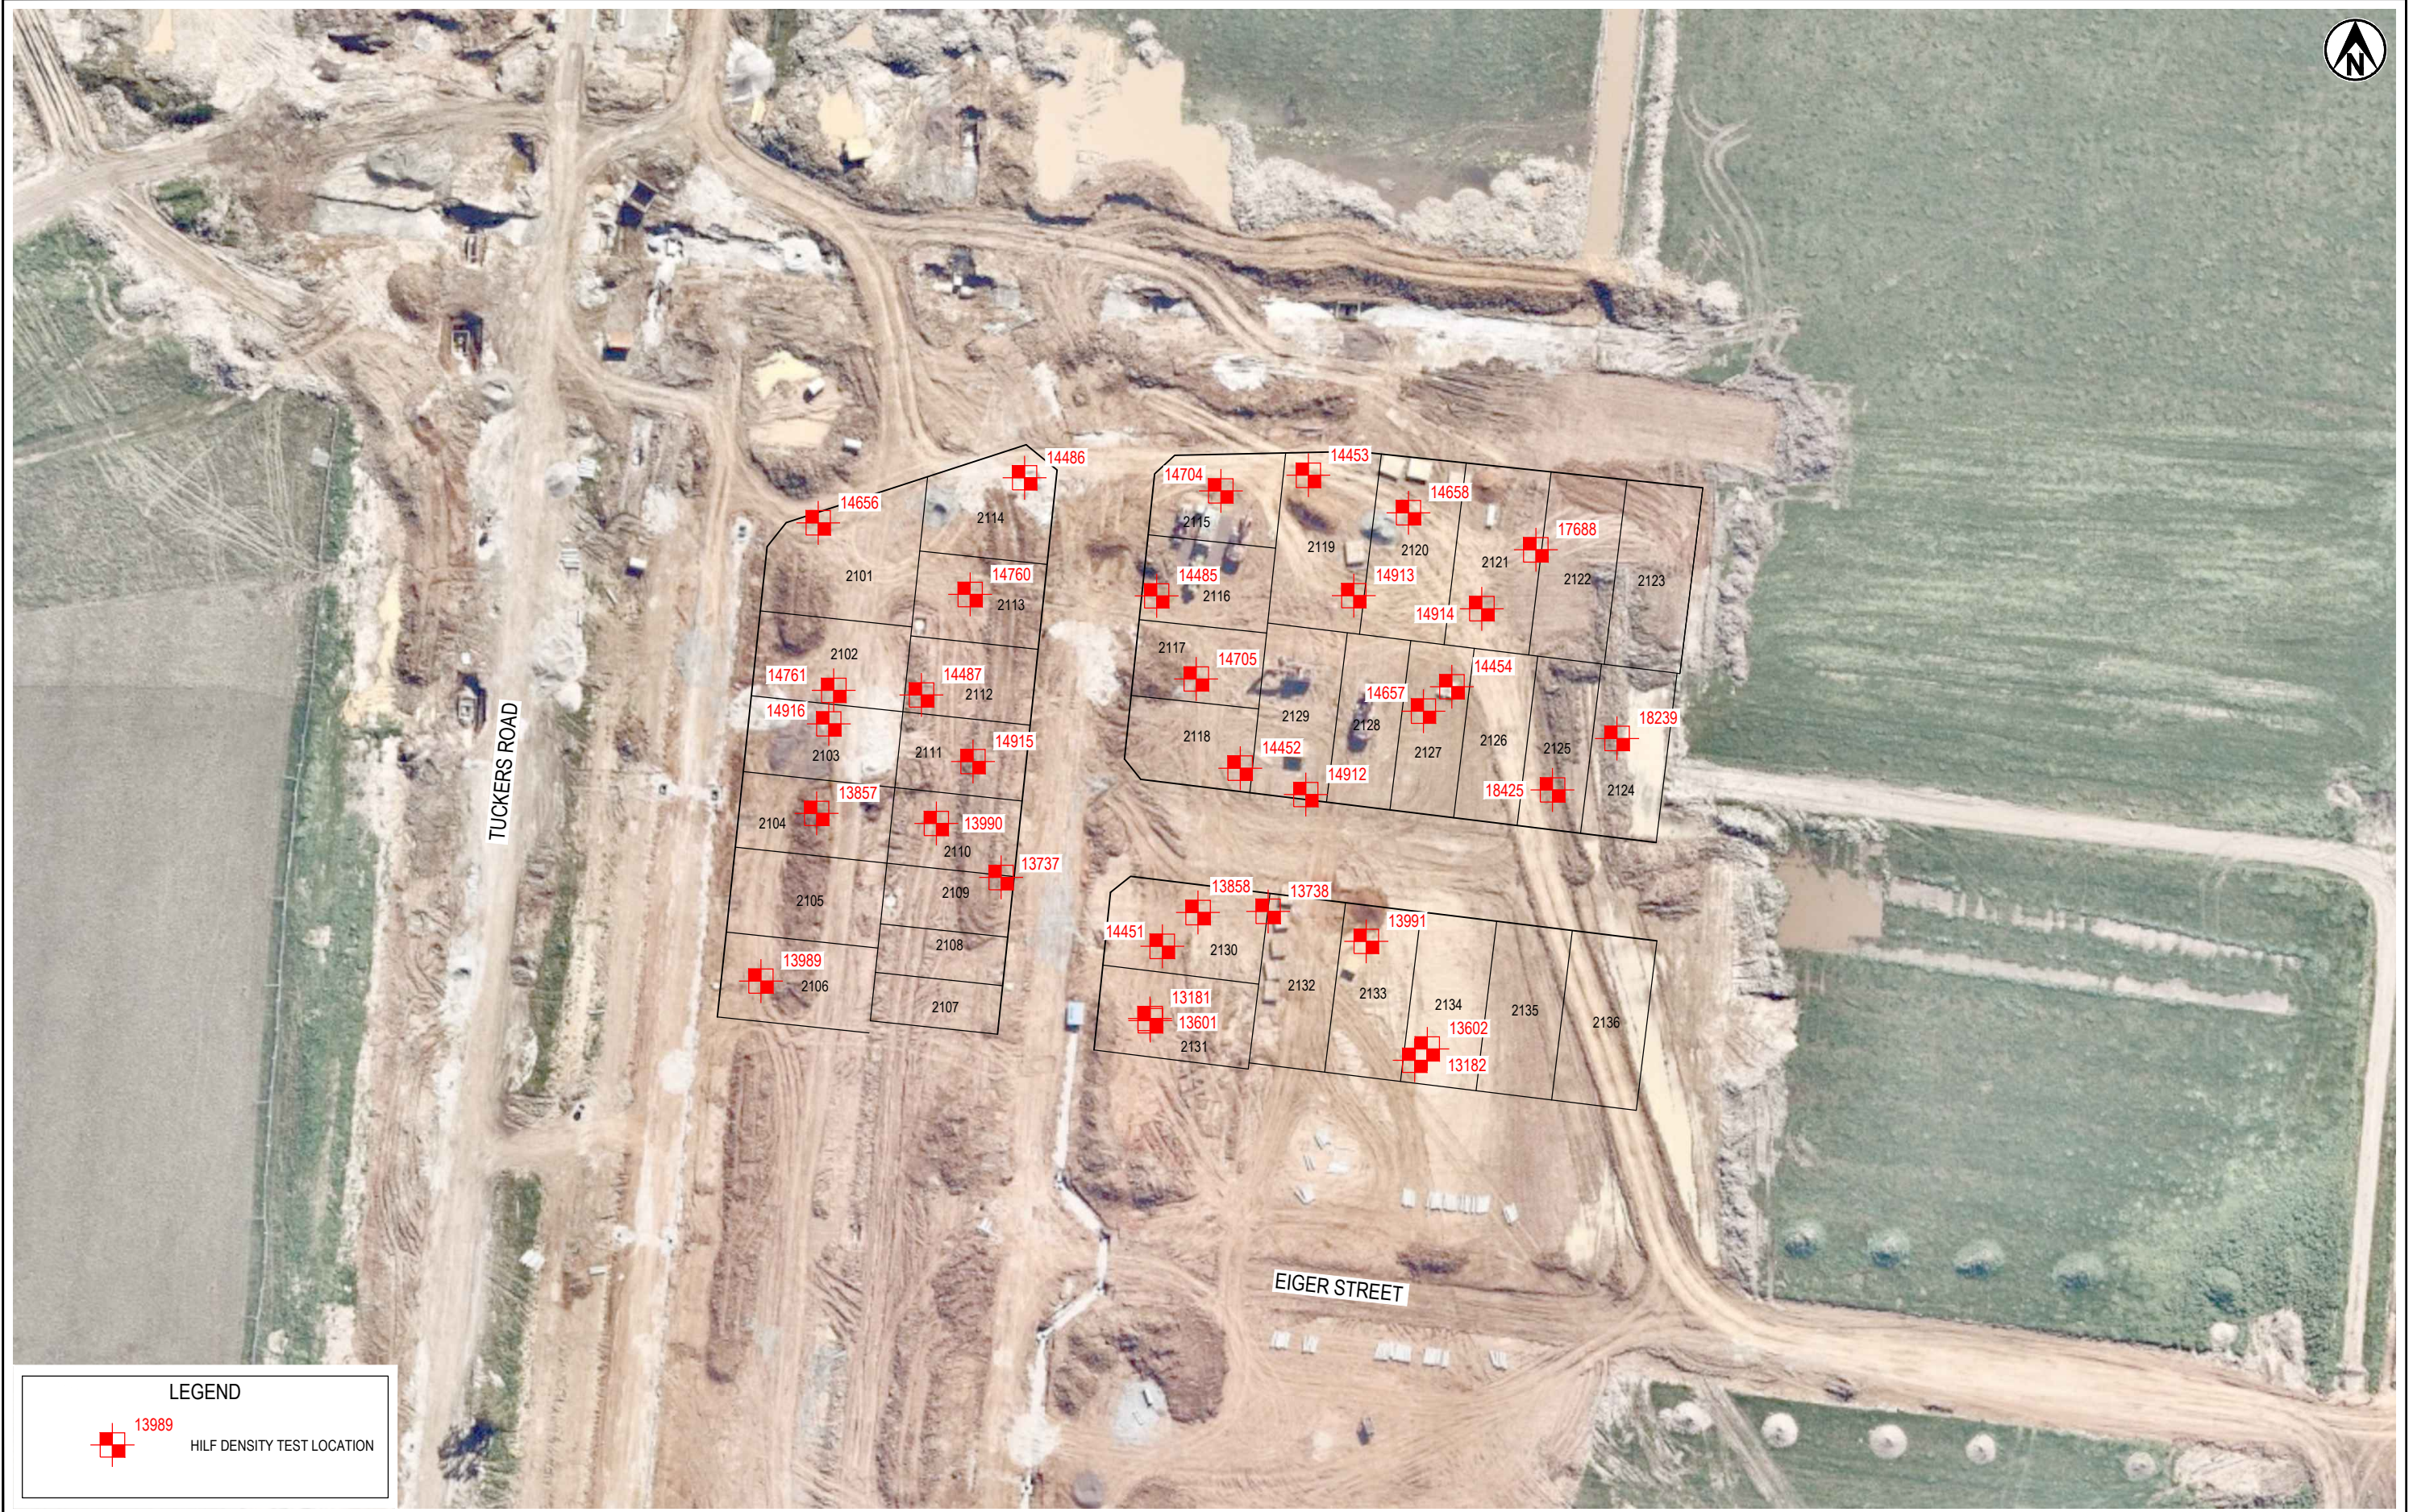
## Appendix A: Density Test Location Plan

Field density and moisture content testing was carried out using a calibrated portable density and moisture gauge in accordance with AS 1289.5.8.1. The HILF rapid compaction test was used for peak converted wet density determinations in accordance with AS 1289.5.7.1. Test locations were recorded using a handheld GPS unit. A site plan showing the field density test locations is provided in Appendix A.

13989  
HILF DENSITY TEST LOCATION
