REPORT

Level One Inspection and Testing Services

Meridian Estate Stage 22, Lots 2201 to 2243

Our Ref: 3807351.022.v1

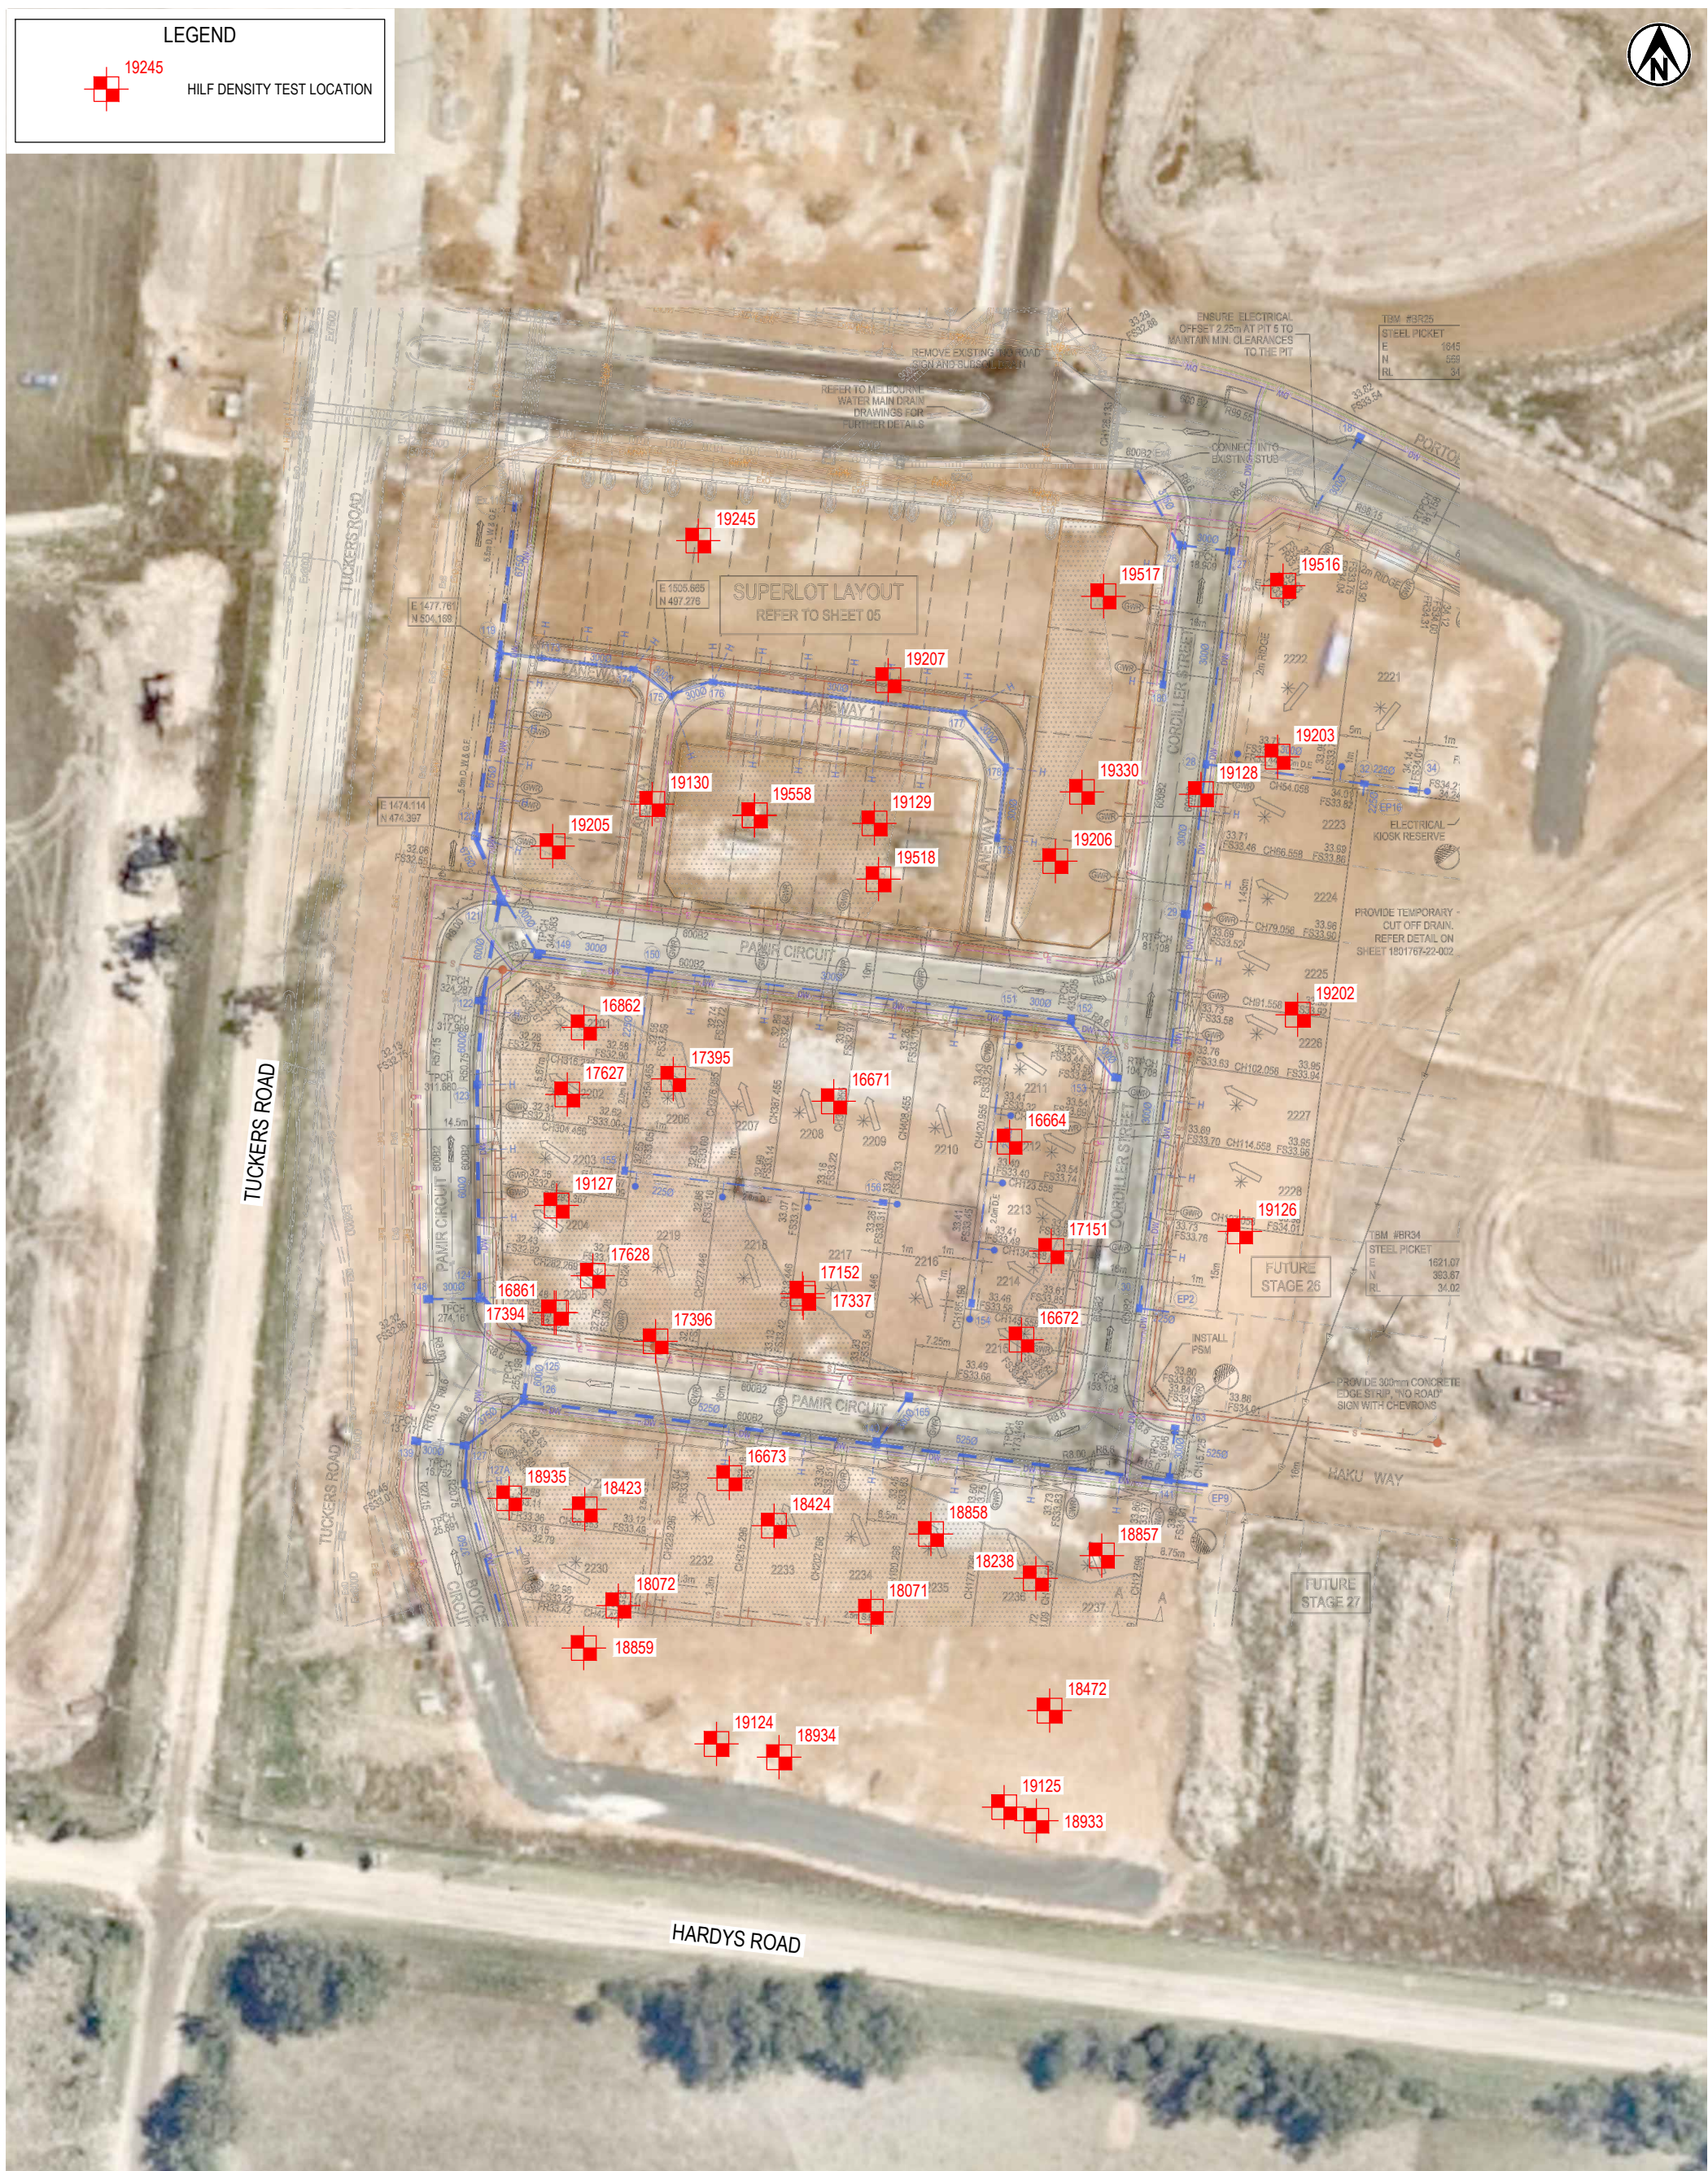
CLIENT	GROSVENOR LODGE PTY LTD	
PROJECT	MERIDIAN ESTATE - STAGE 22	
TITLE	LEVEL ONE HILF DENSITY TESTING HILF DENSITY TEST PLAN	
SCALE (A3)	1:1000	FIG No. FIGURE 01
REV	1

Field density and moisture content testing was carried out using a calibrated portable density and moisture gauge in accordance with AS 1289.5.8.1. The HILF rapid compaction test was used for peak converted wet density determinations in accordance with AS 1289.5.7.1. Test locations were recorded using a handheld GPS unit. A site plan showing the field density test locations is provided in Appendix A.

A total of forty four (44) tests were performed during the filling process.

The results show that two (2) tests failed to meet the specification requirements for the project. The earthworks contractor was advised of the tests that failed and the fill relevant to those areas was reworked, reconditioned, re-compacted and subsequently retested. The final results show the tests achieved the specification requirements for the project.
