# REPORT

## Level One Inspection and Testing Services

Meridian Central Estate Stage 25, Clyde  
Lot's 2512 to 2523 and 2527 to Lot 2536

Our Ref: 3807351.025.v1

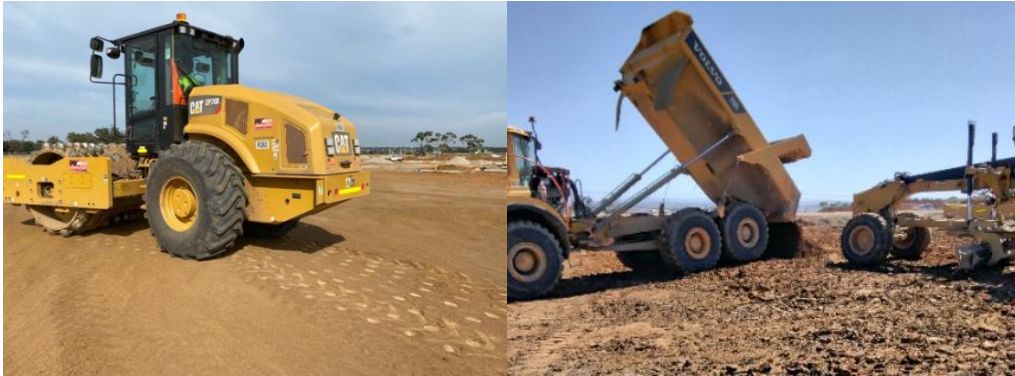
Photograph 2.1:

All fill material was placed in lift sequences and Chadwick Geotechnics verified that the surface of the stripped subgrade and additional lifts were thoroughly scarified, and moisture conditioned prior to placement of additional layers to prevent delamination at the layer interface. See Photographs 2.1 and 2.2 below.

Earthwork compaction March, 2021

Material delivery, March 2021
