Level 1 Geotechnical Testing and Inspection Authority Services

**Meridian Green Estate Clyde North
Stage 47**

**Lots 4701 to 4712 and 4715, 4716 and 4724
to 4747**

16 February 2024

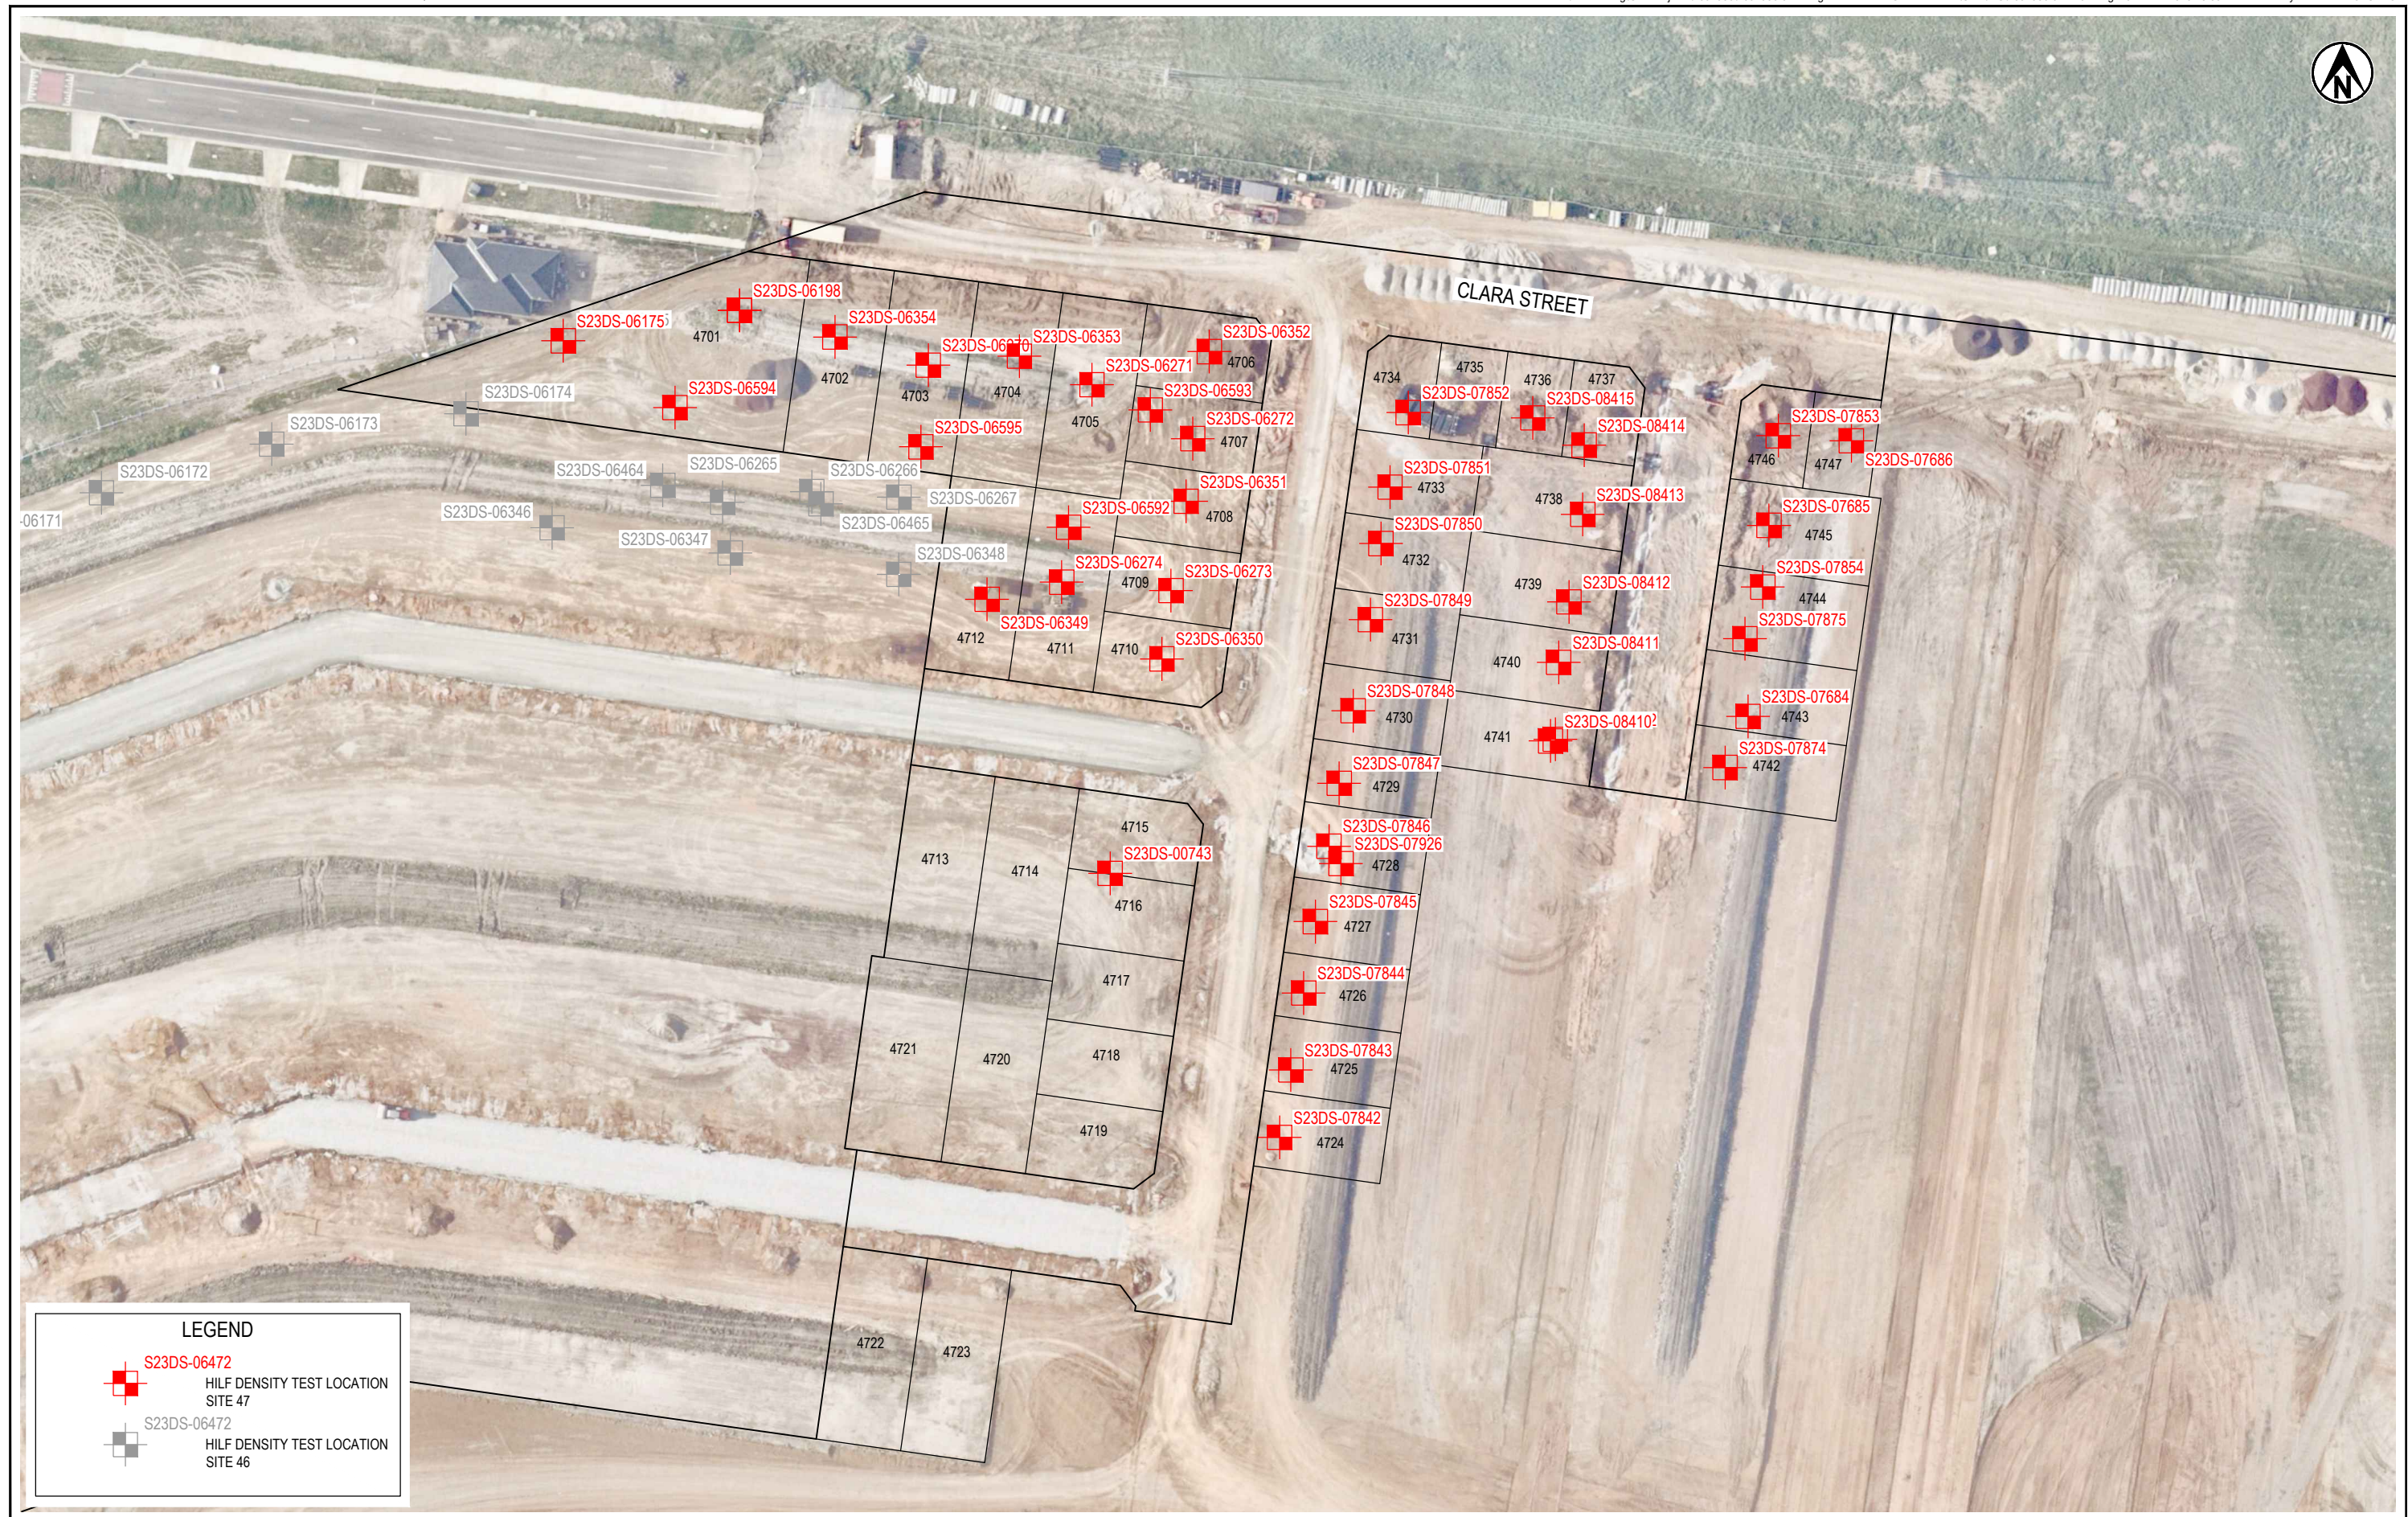
Appendix A Test Location Plan

Field density and moisture content testing was undertaken progressively during construction on the compacted fill using a calibrated portable density and moisture gauge in accordance with AS 1289.5.8.1. The HILF rapid compaction test was used for peak converted wet density determinations in accordance with AS 1289.5.7.1. Test locations were recorded using a handheld GPS unit. A site plan showing the field density test locations is provided in **Appendix A**.
