# REPORT

## Level One Inspection and Testing Services

Meridian Estate Stage 16, Lot's 1601 to  
1656.

Grosvenor Lodge Pty Ltd

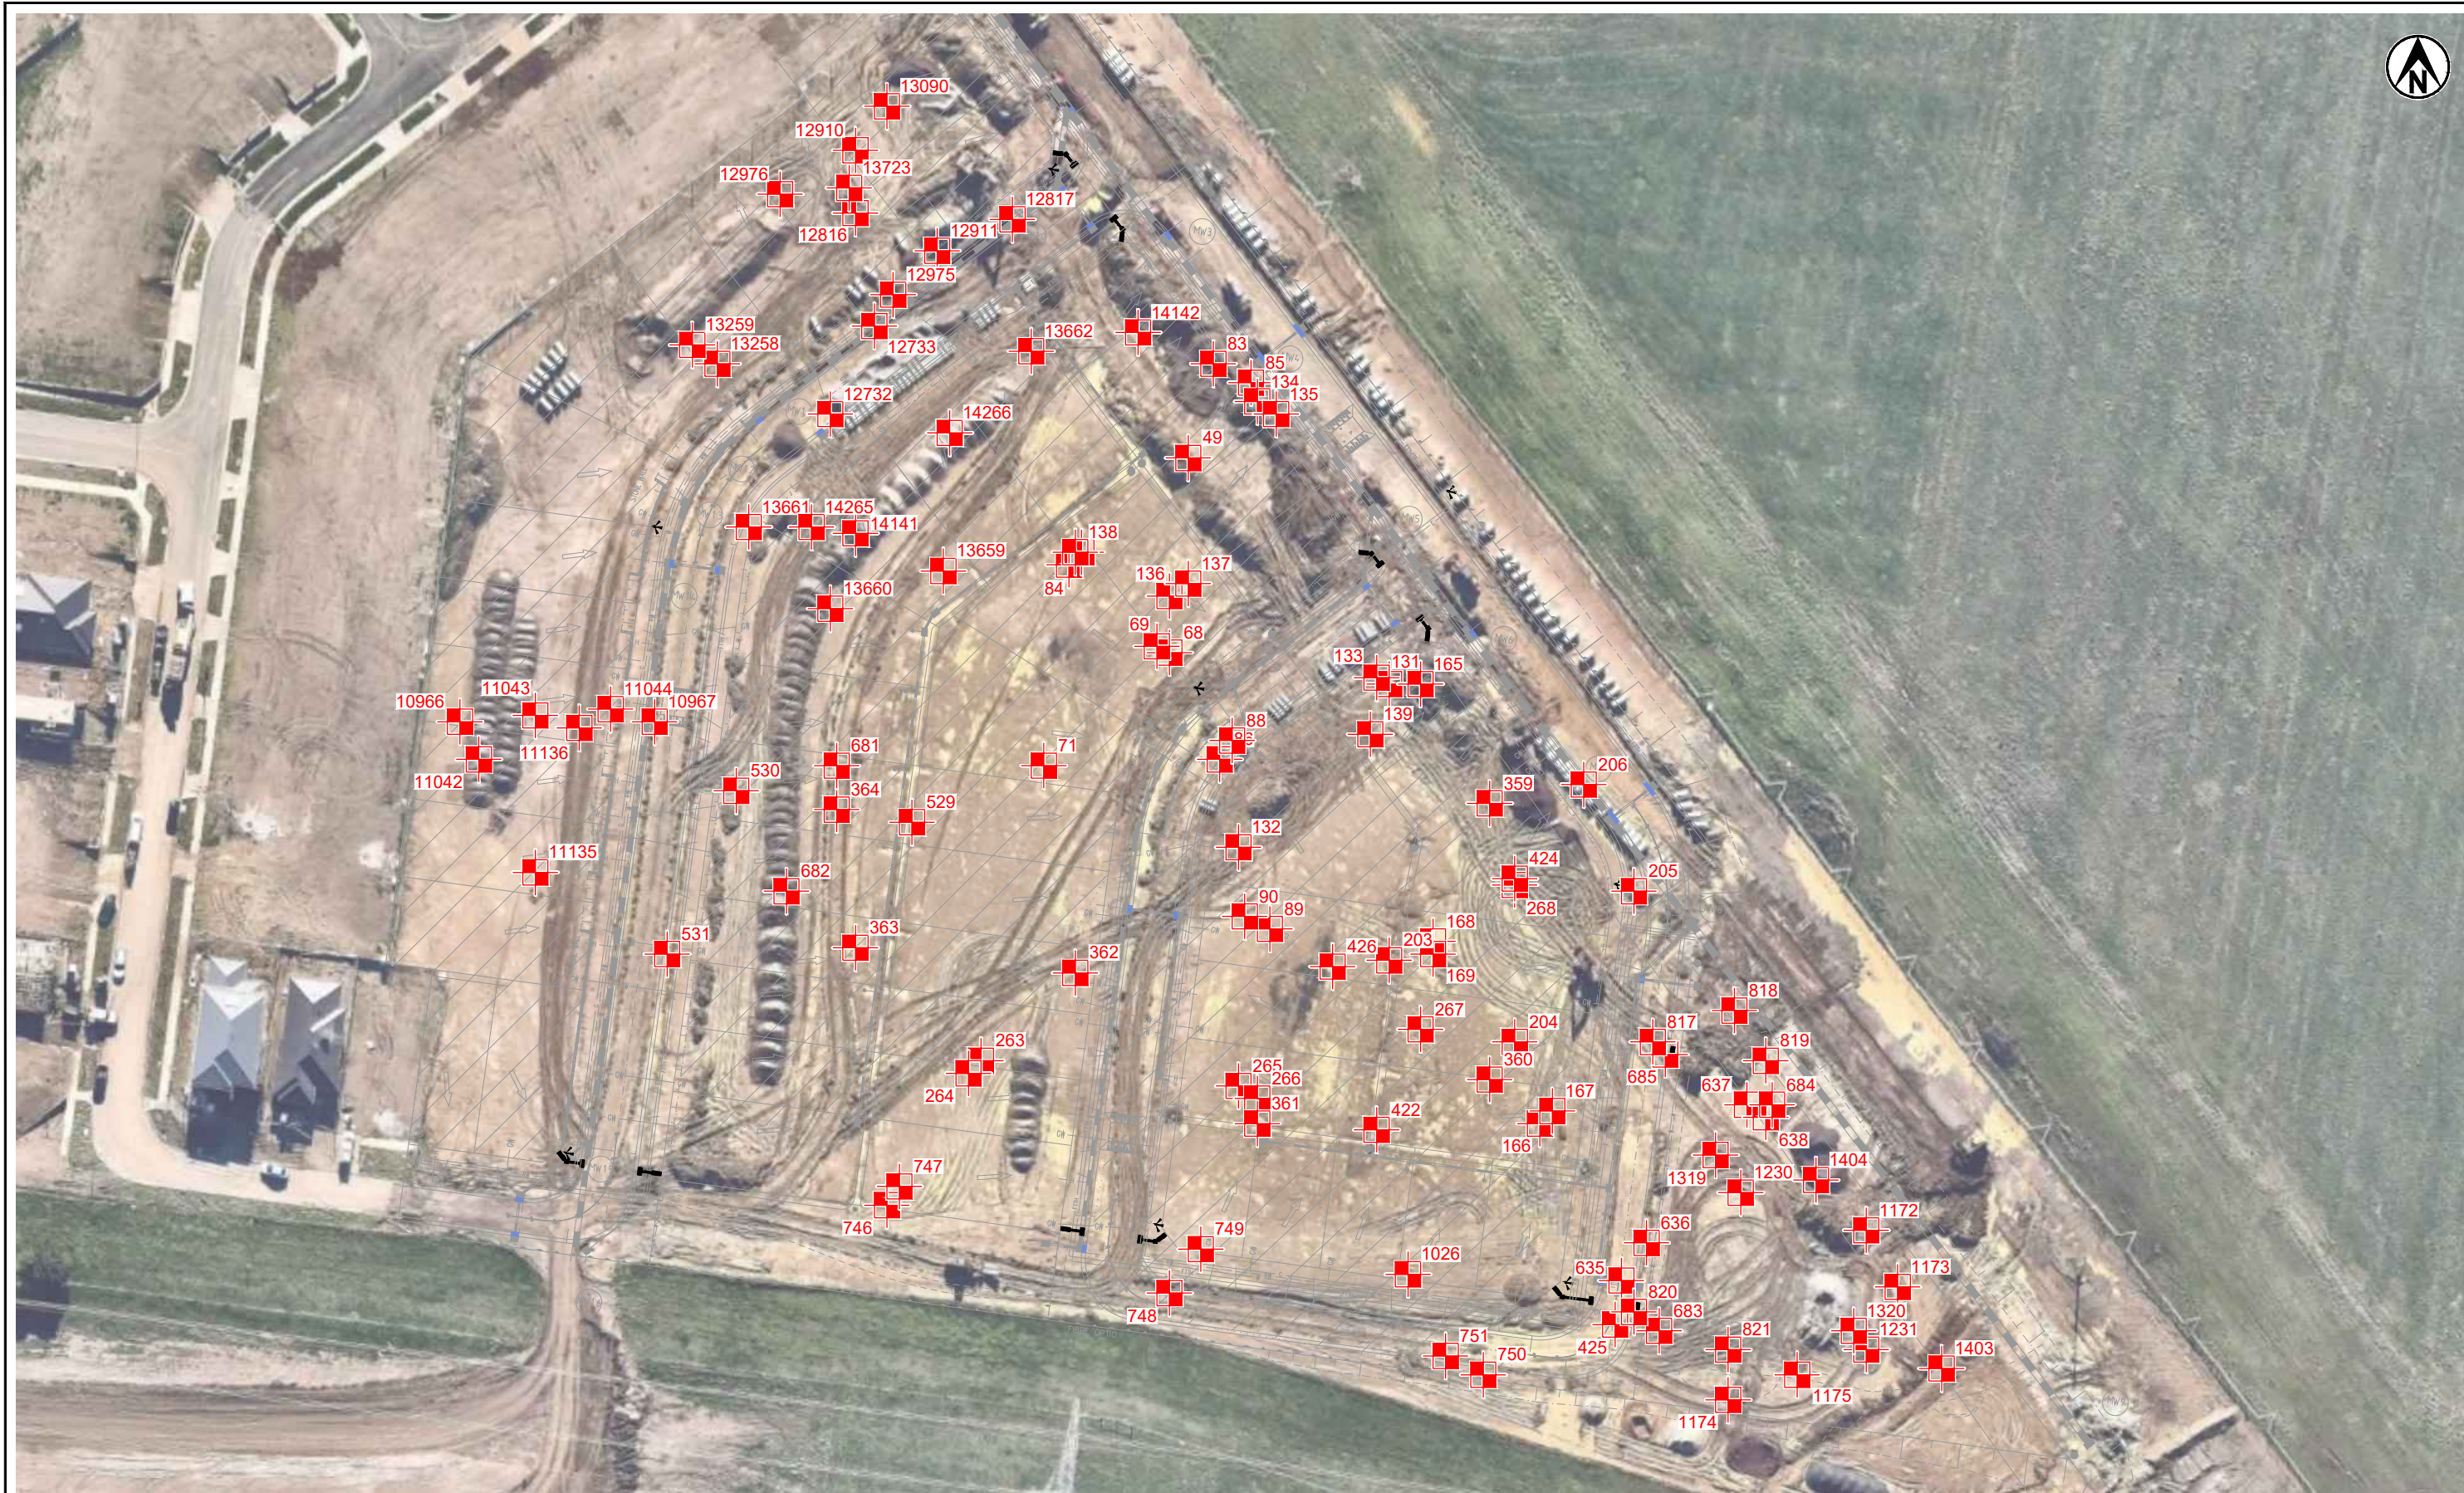
## Appendix A: Density Test Location Plan

NOTES:  
 1. ROAD AND DRAINAGE PLAN RECEIVED BY BROWN PROPERTY GROUP. REF: 8129-16-E-R&D-P4-Road & Drainage plans. DATE: 13/02/2019.

Field density and moisture content testing was carried out using a calibrated nuclear density gauge in accordance with AS 1289.5.8.1. The HILF rapid compaction test was used for peak converted wet density determinations in accordance with AS 1289.5.7.1. Test locations were recorded using a handheld GPS unit. A site plan showing the field density test locations is provided in Appendix A.
